Monitoring of Forestry BMPs in Michigan Fall 2011

*Prepared by Dr. Larry Pedersen
For the Michigan SFI® Implementation Committee
April, 2012*

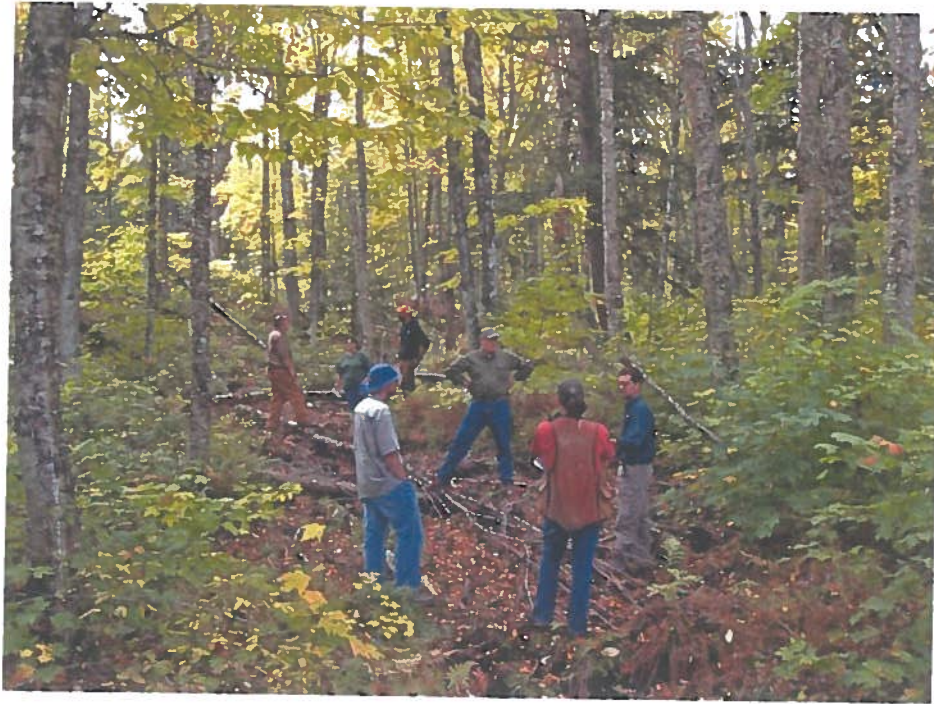
The audit team discussing RMZ management and stream classification along an intermittent stream.

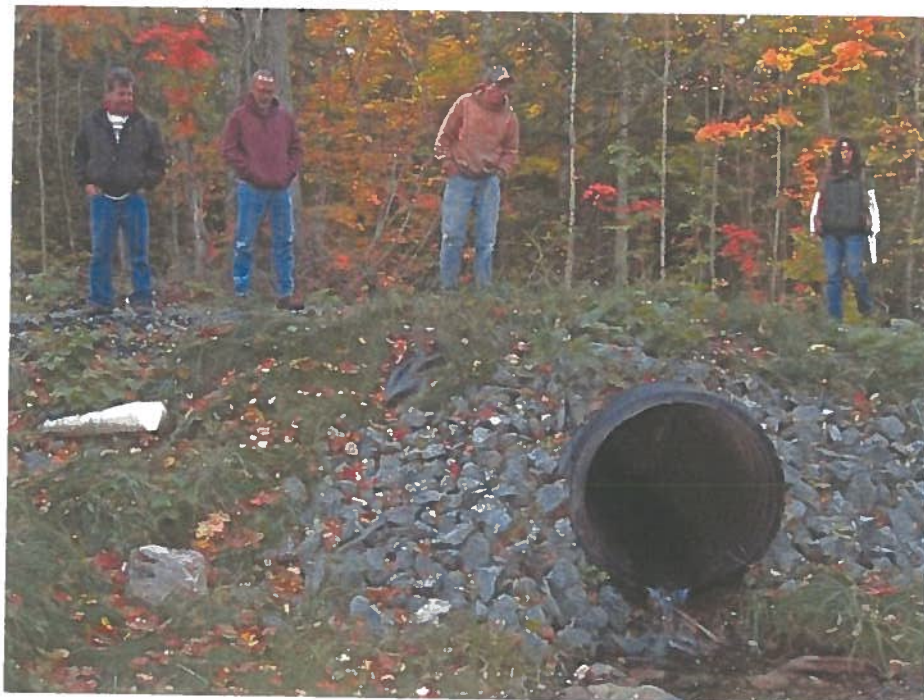
Auditors discuss perched culvert placed over bedrock.

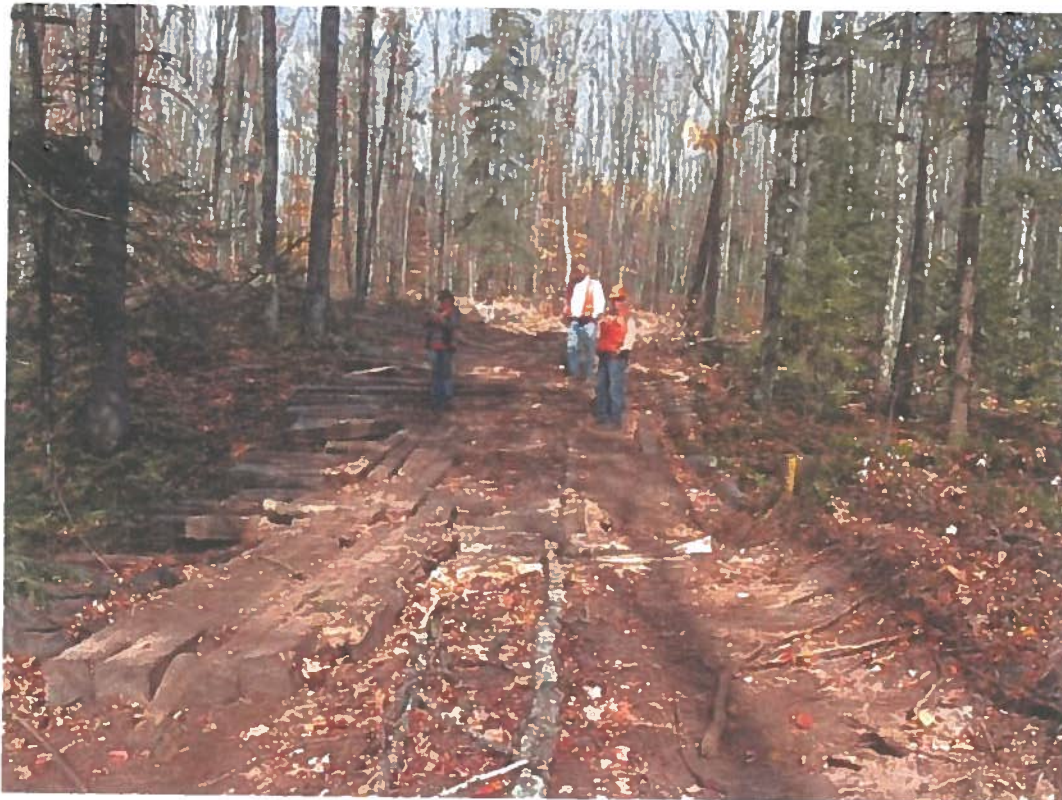
The audit team discussing use of timber mats to cross a seasonally wet area.
