# Dam Removal & River Restoration Projects in Northwest Michigan

Conservation  
Resource Alliance

# Boardman River Dams

# Lake Kathleen Dam Removal & Woodland Bridge Project on the Maple River

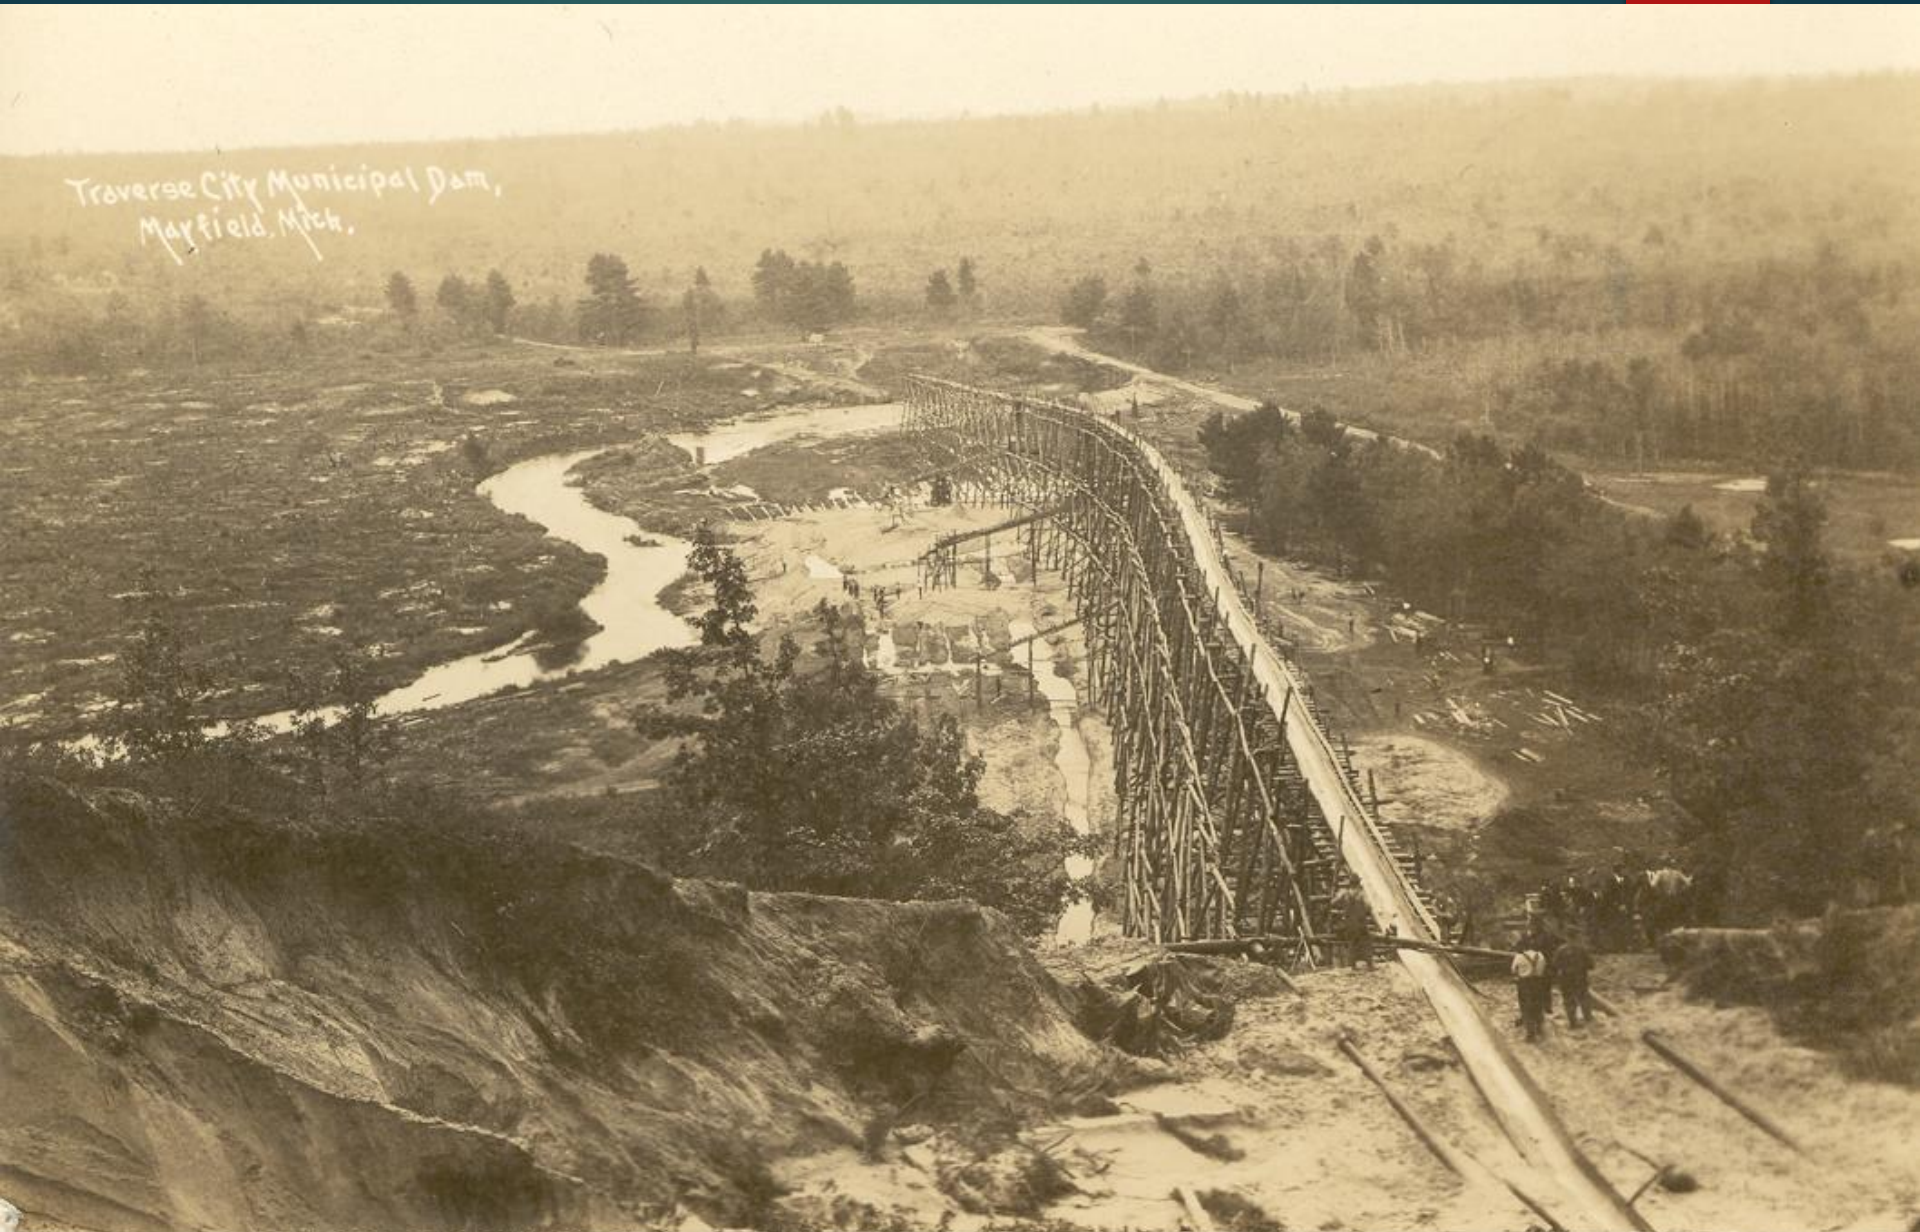
# Brown Bridge Dam built in 1921, earthen embankment was 1,650' long

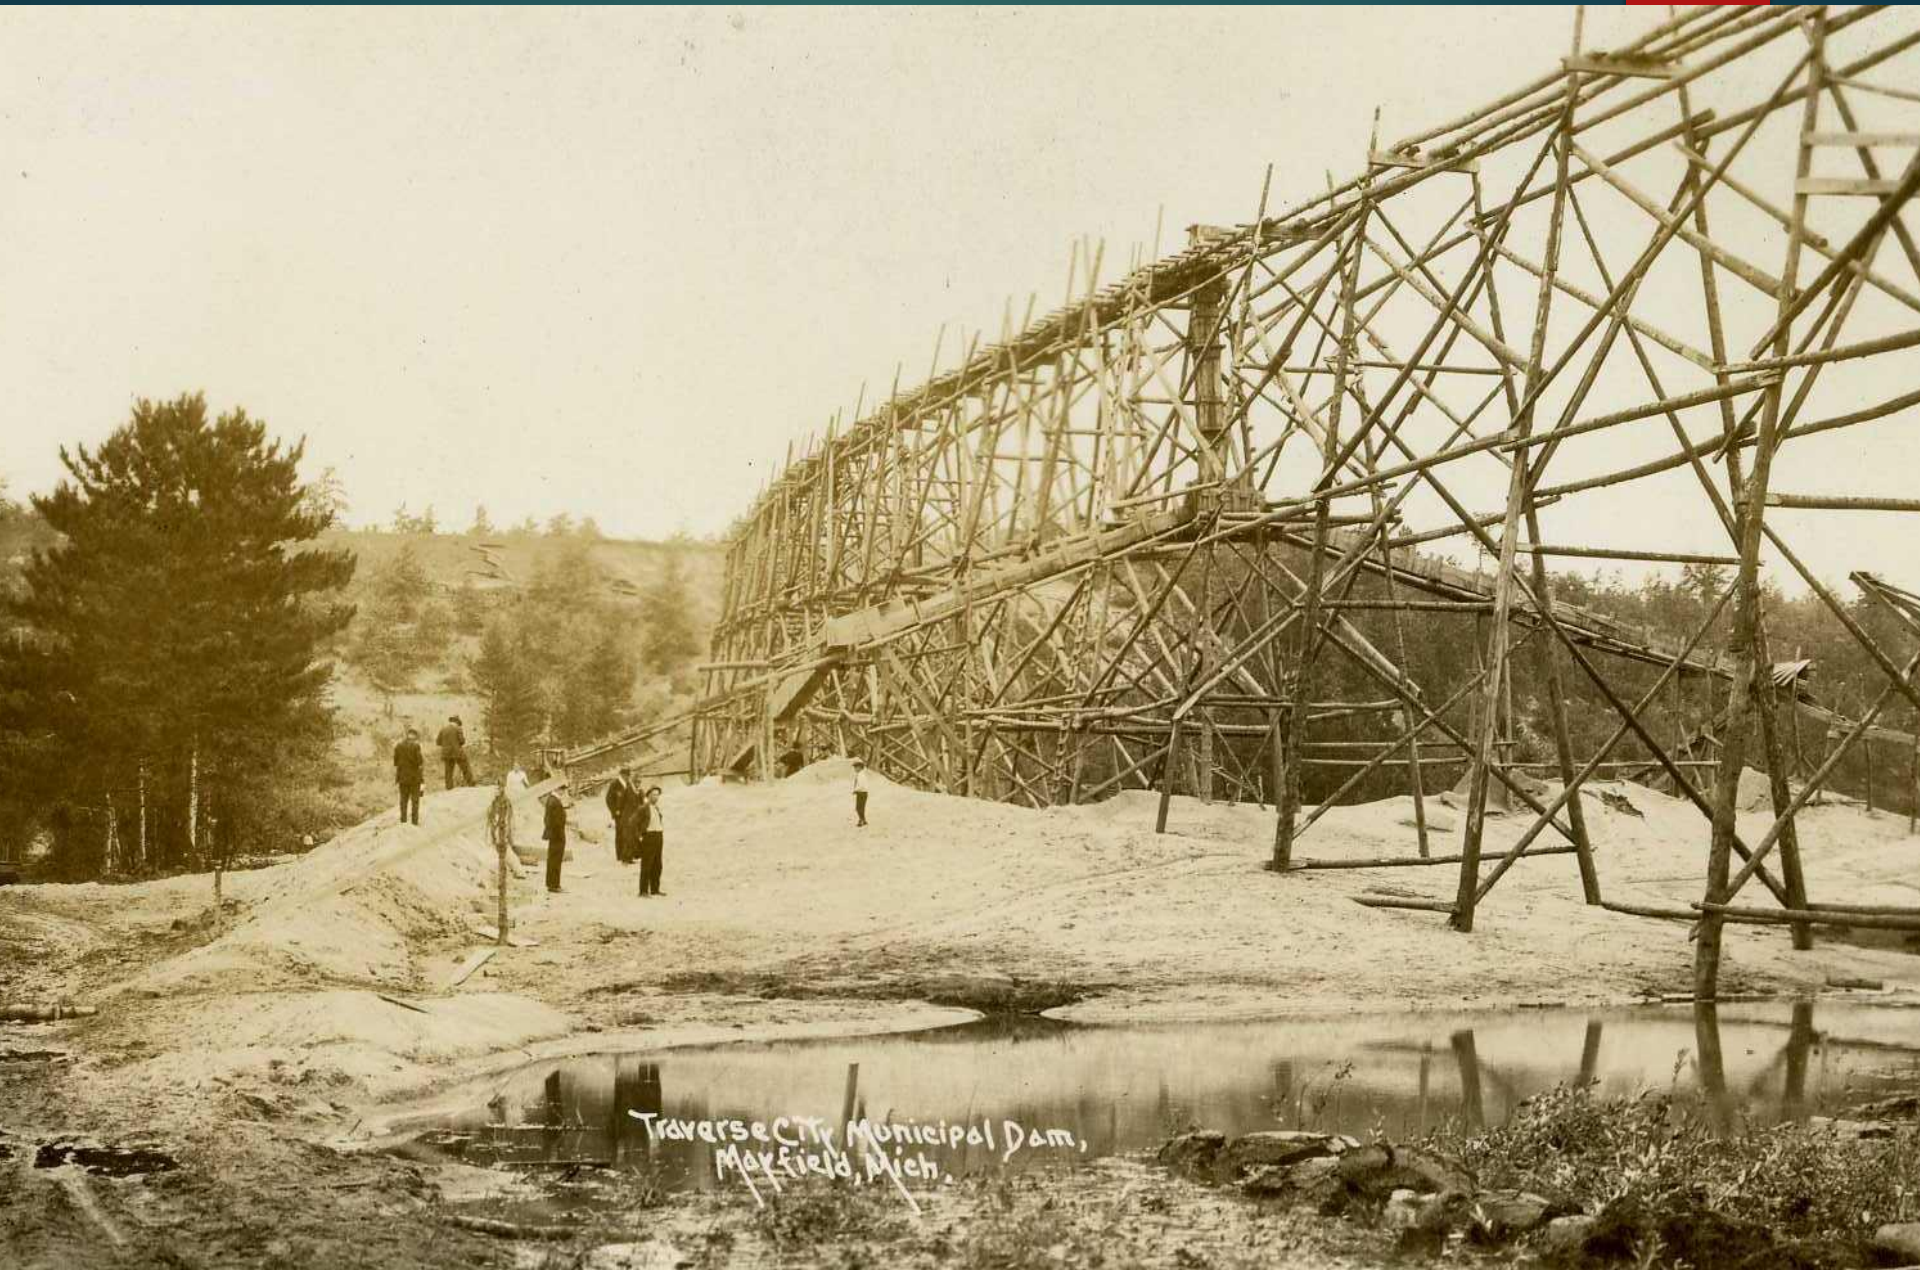
Core wall was 46' high

Traverse City Municipal Dam,  
Maxfield, Mich.

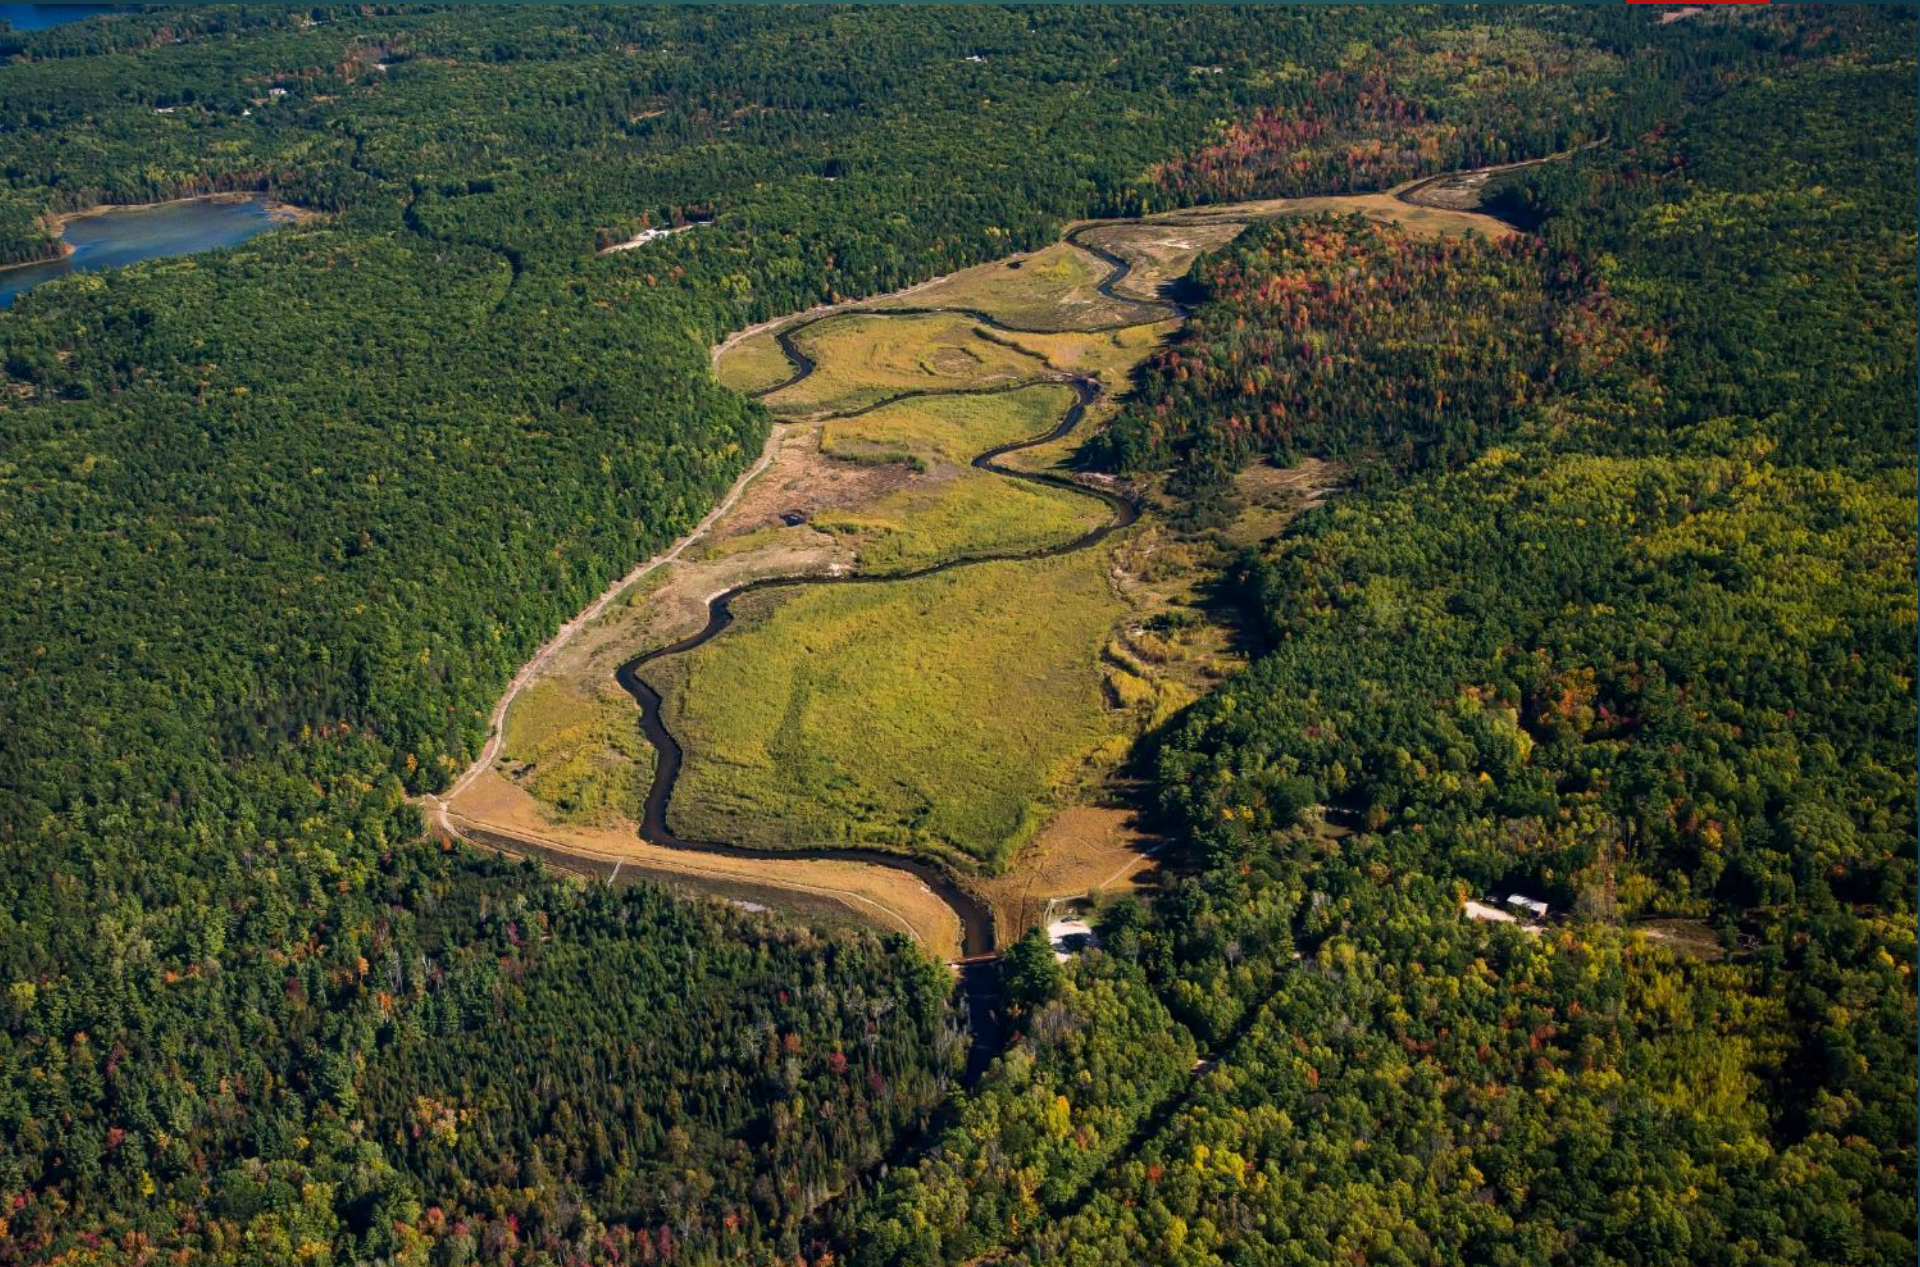
A wide river flows through a landscape, with a large, light-colored sediment wedge in the foreground. The river is surrounded by green and yellow trees, and a forested ridge is visible in the background under a blue sky with white clouds. The text "The 'sediment wedge.'" is overlaid on the image.

The "sediment wedge."

Ultimate sediment management, 277,000 cyds.

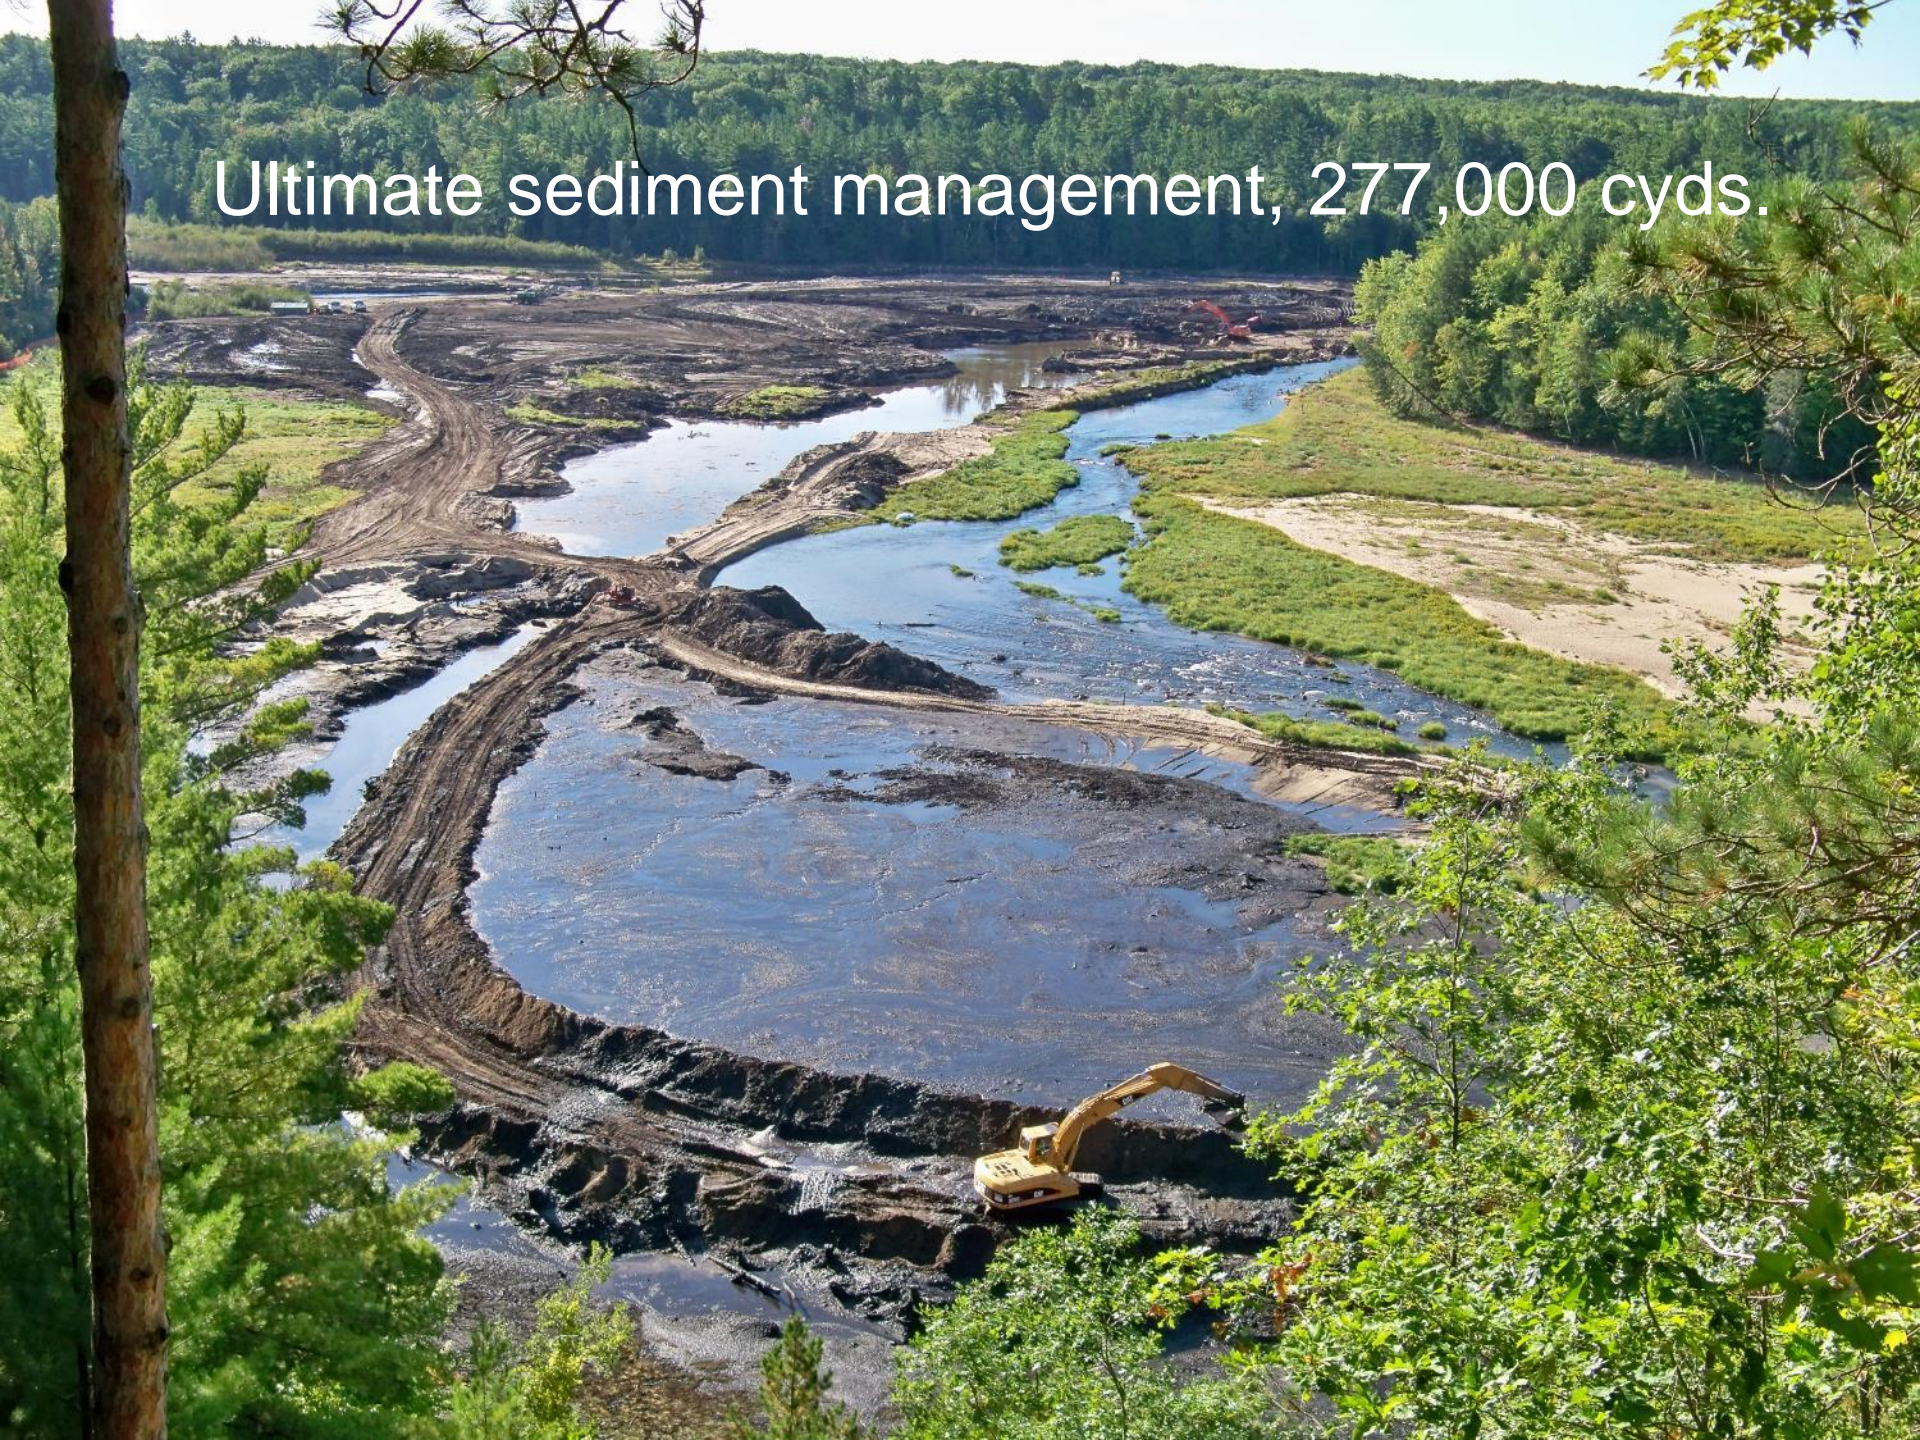
An aerial photograph showing a river meandering through a wide, green floodplain. The river is dark and narrow, curving from the upper left towards the lower right. The surrounding land is covered in lush green grass and yellow wildflowers. In the background, a dense, dark green forest stretches across the horizon under a cloudy sky. The foreground is framed by the tops of various trees, including pines and deciduous species.

Average river width 45',  
floodplain width 30'.

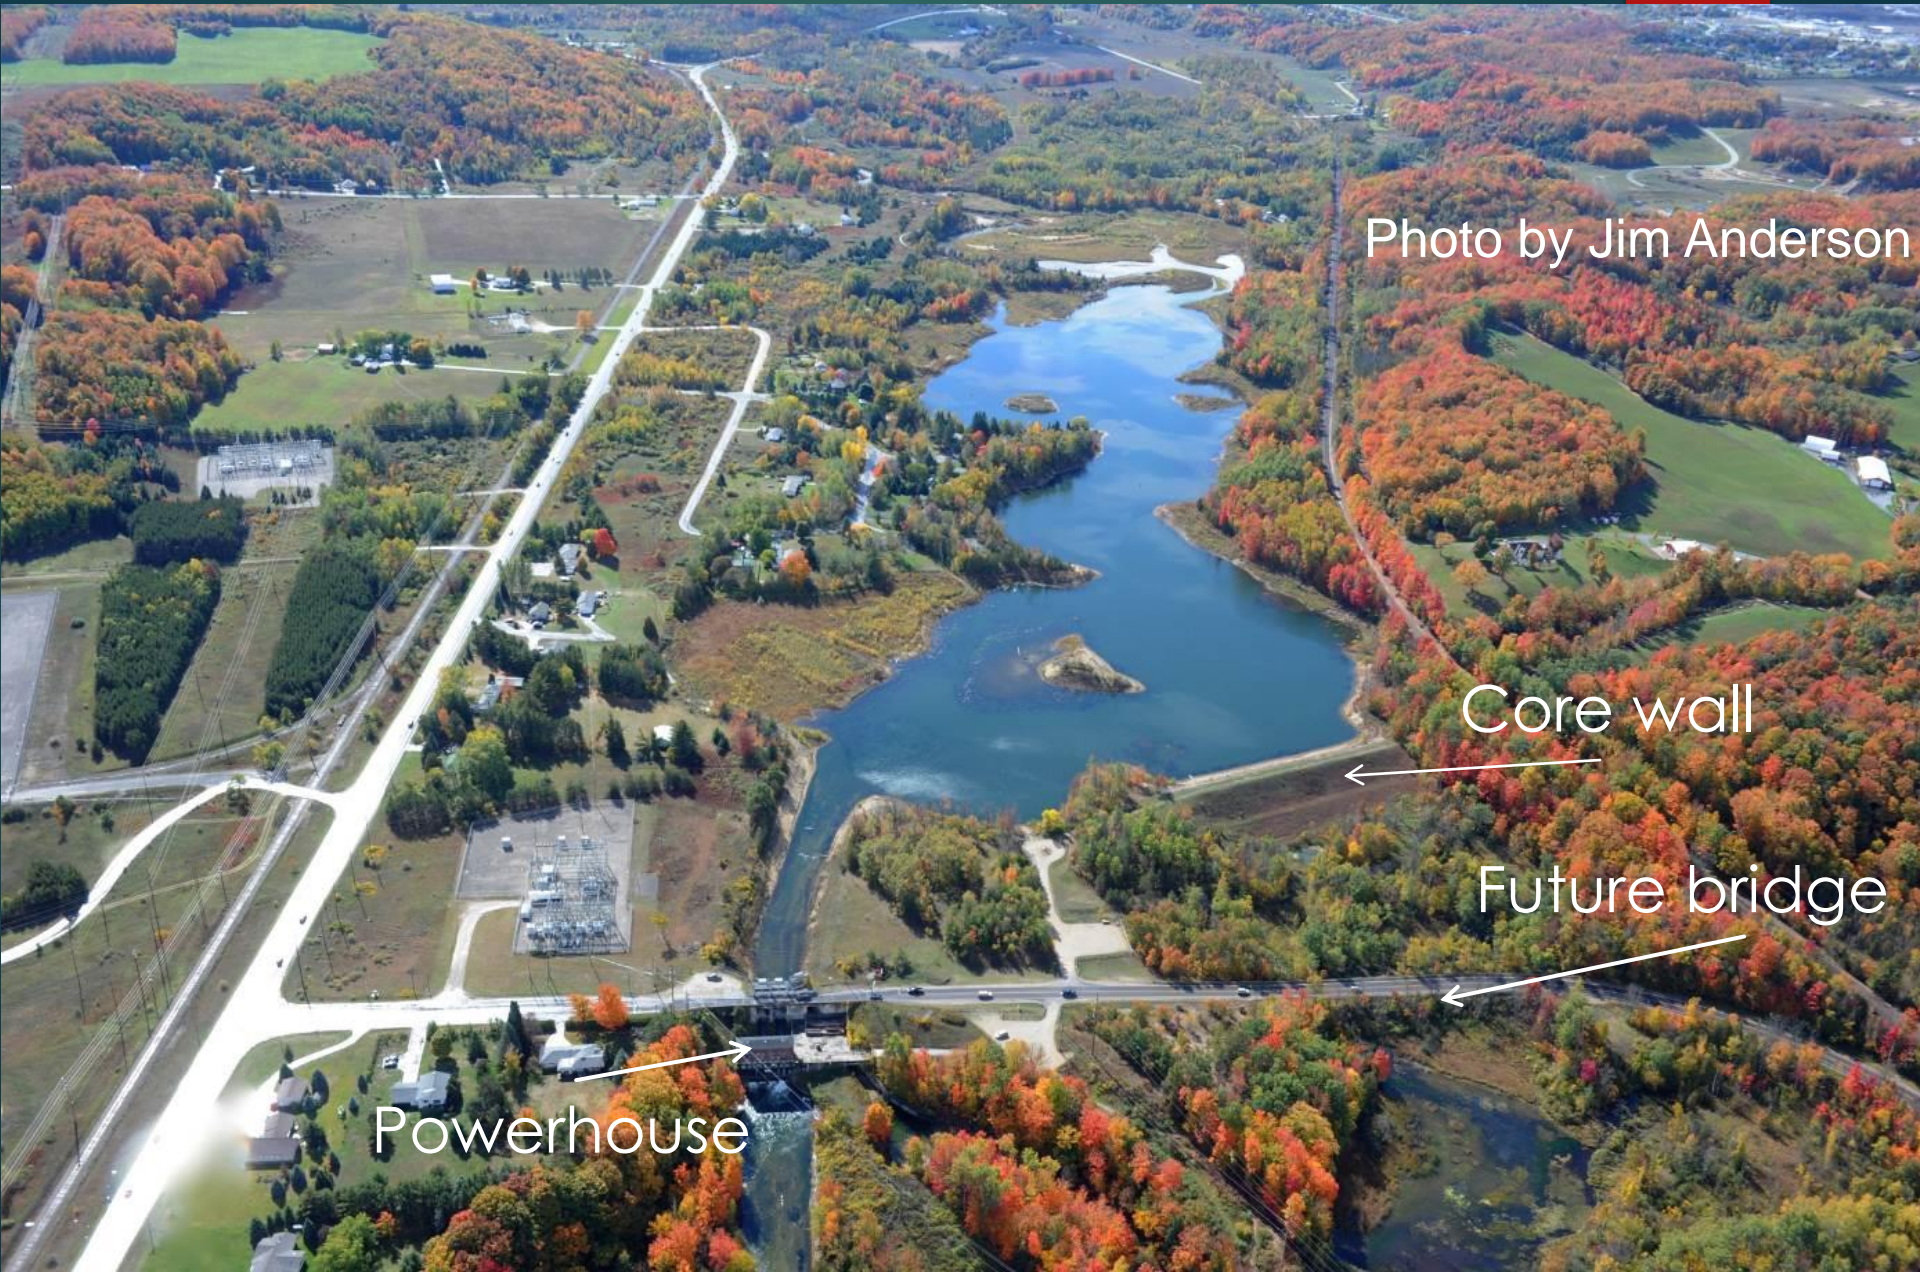
# Boardman Dam & Pond – October 2012

Core wall

Future bridge

Powerhouse

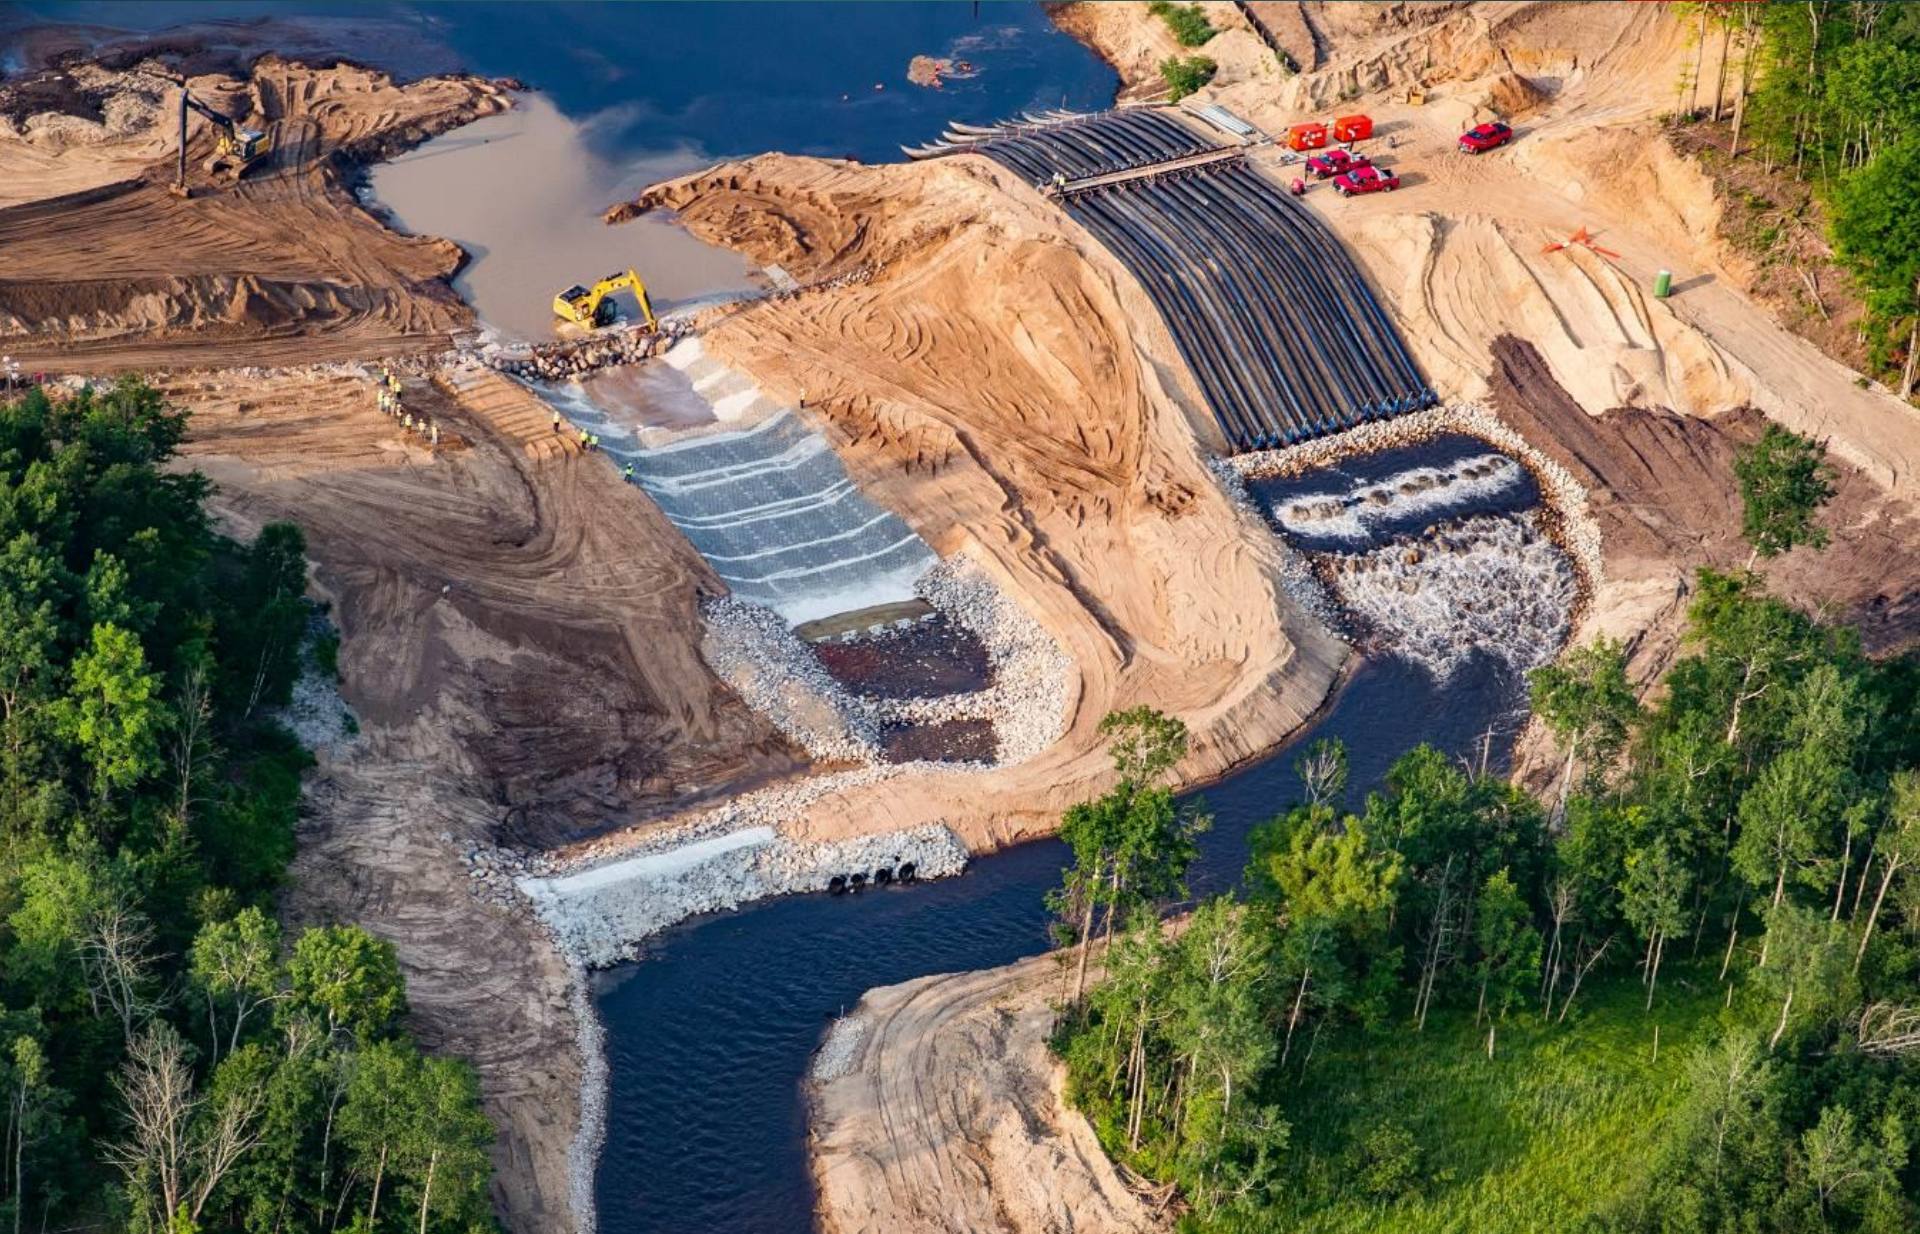
# Dewatering – 14 gravity fed siphons & a concrete auxiliary channel

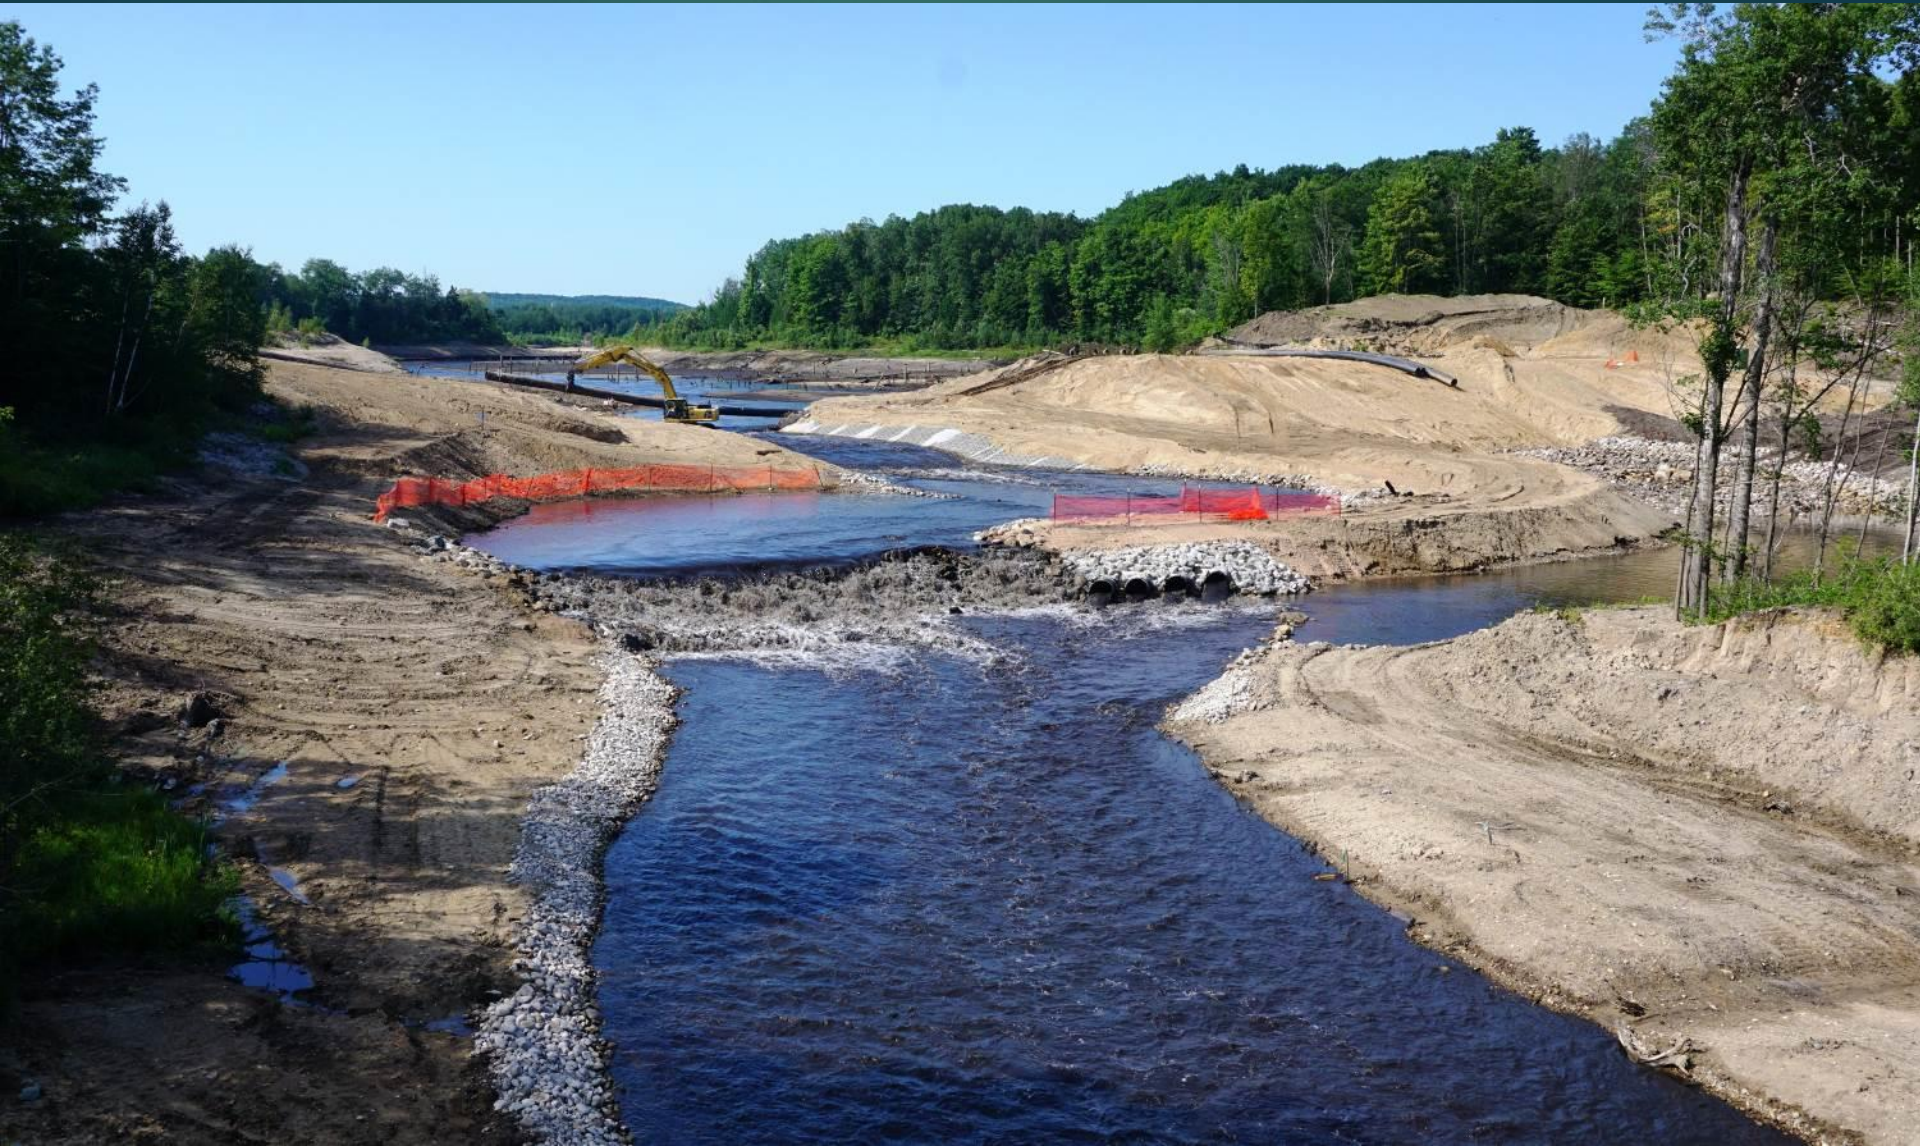
# Siphons taken off-site & auxiliary channel takes over

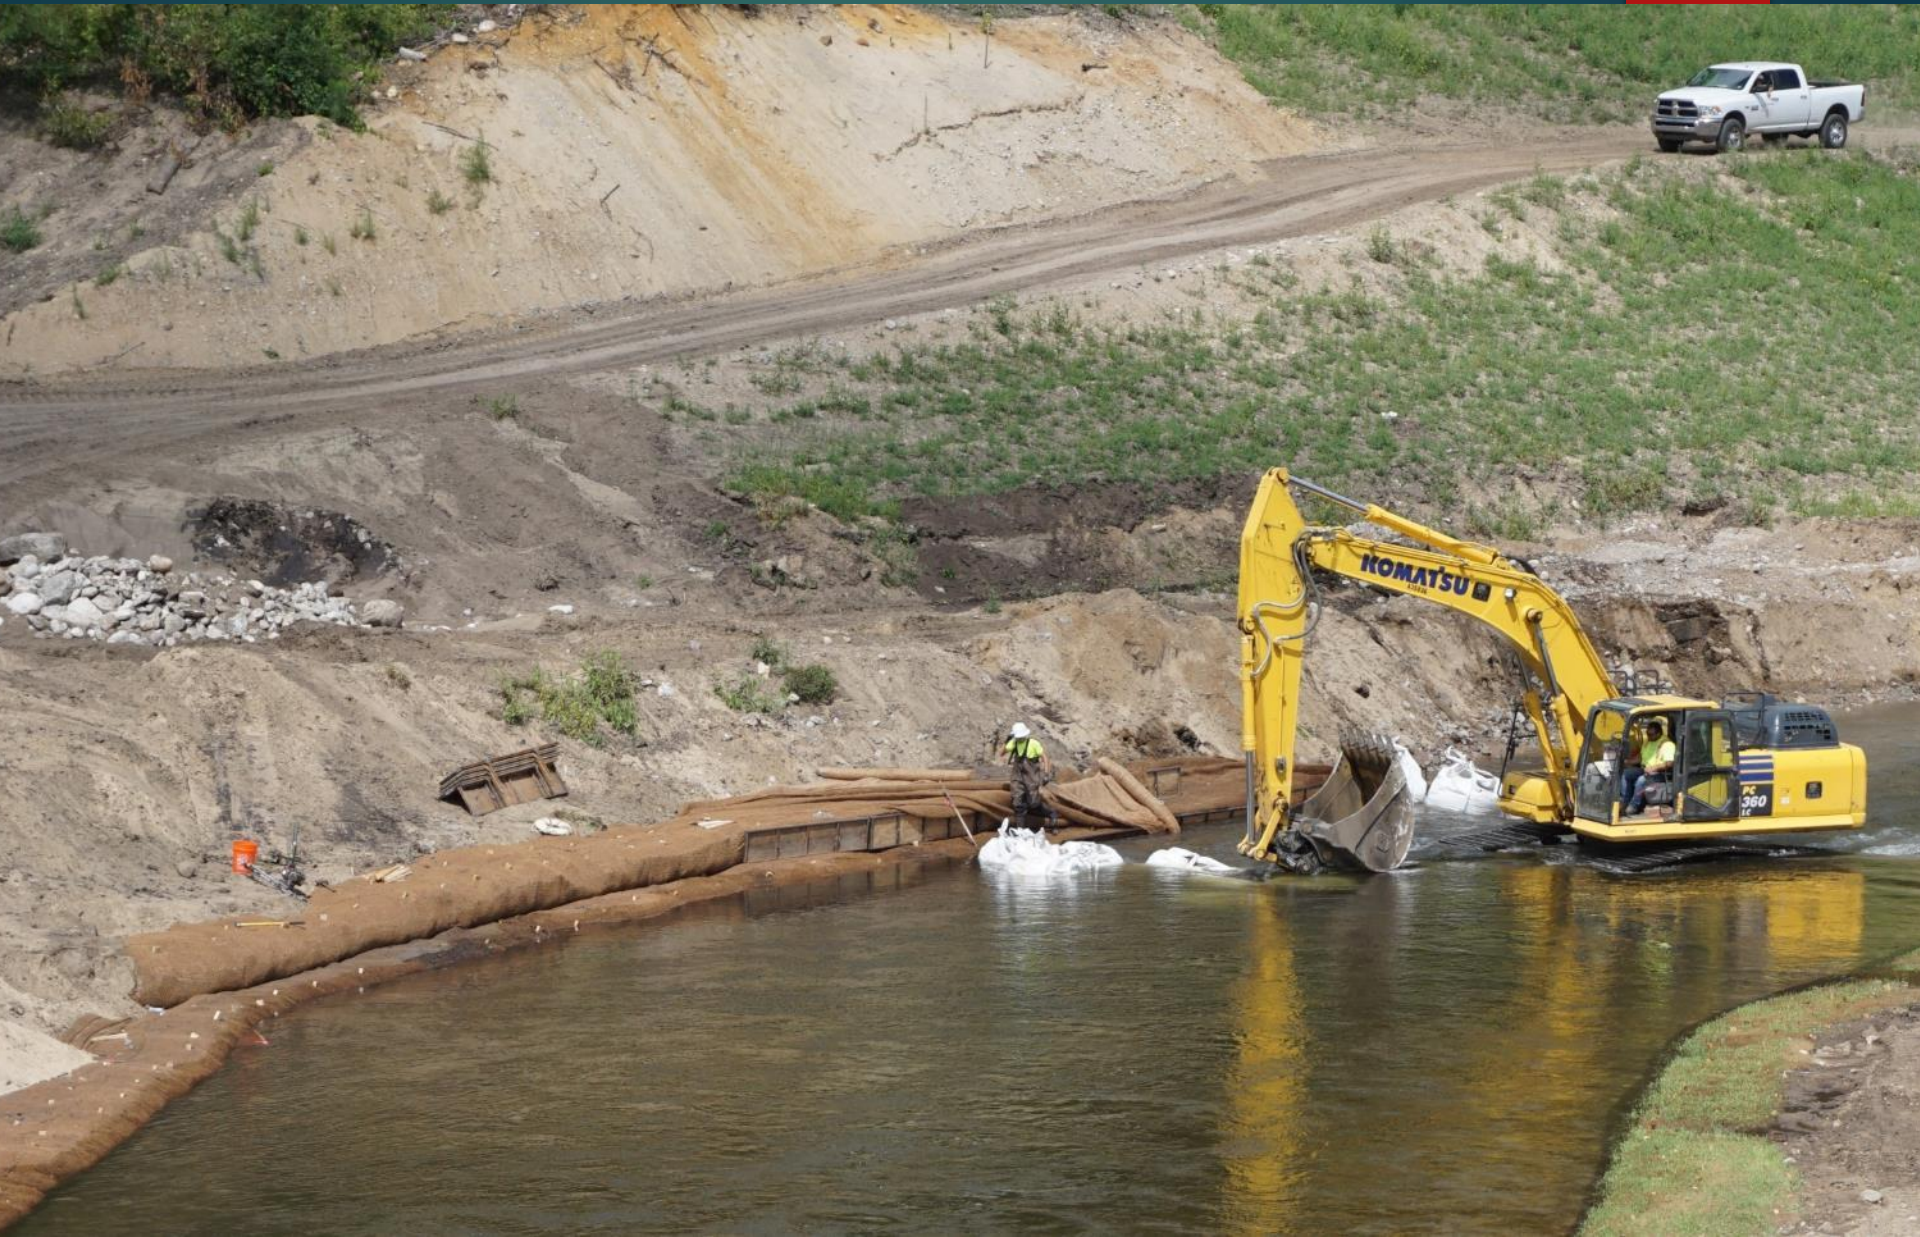
# Fabric encapsulated soil lifts

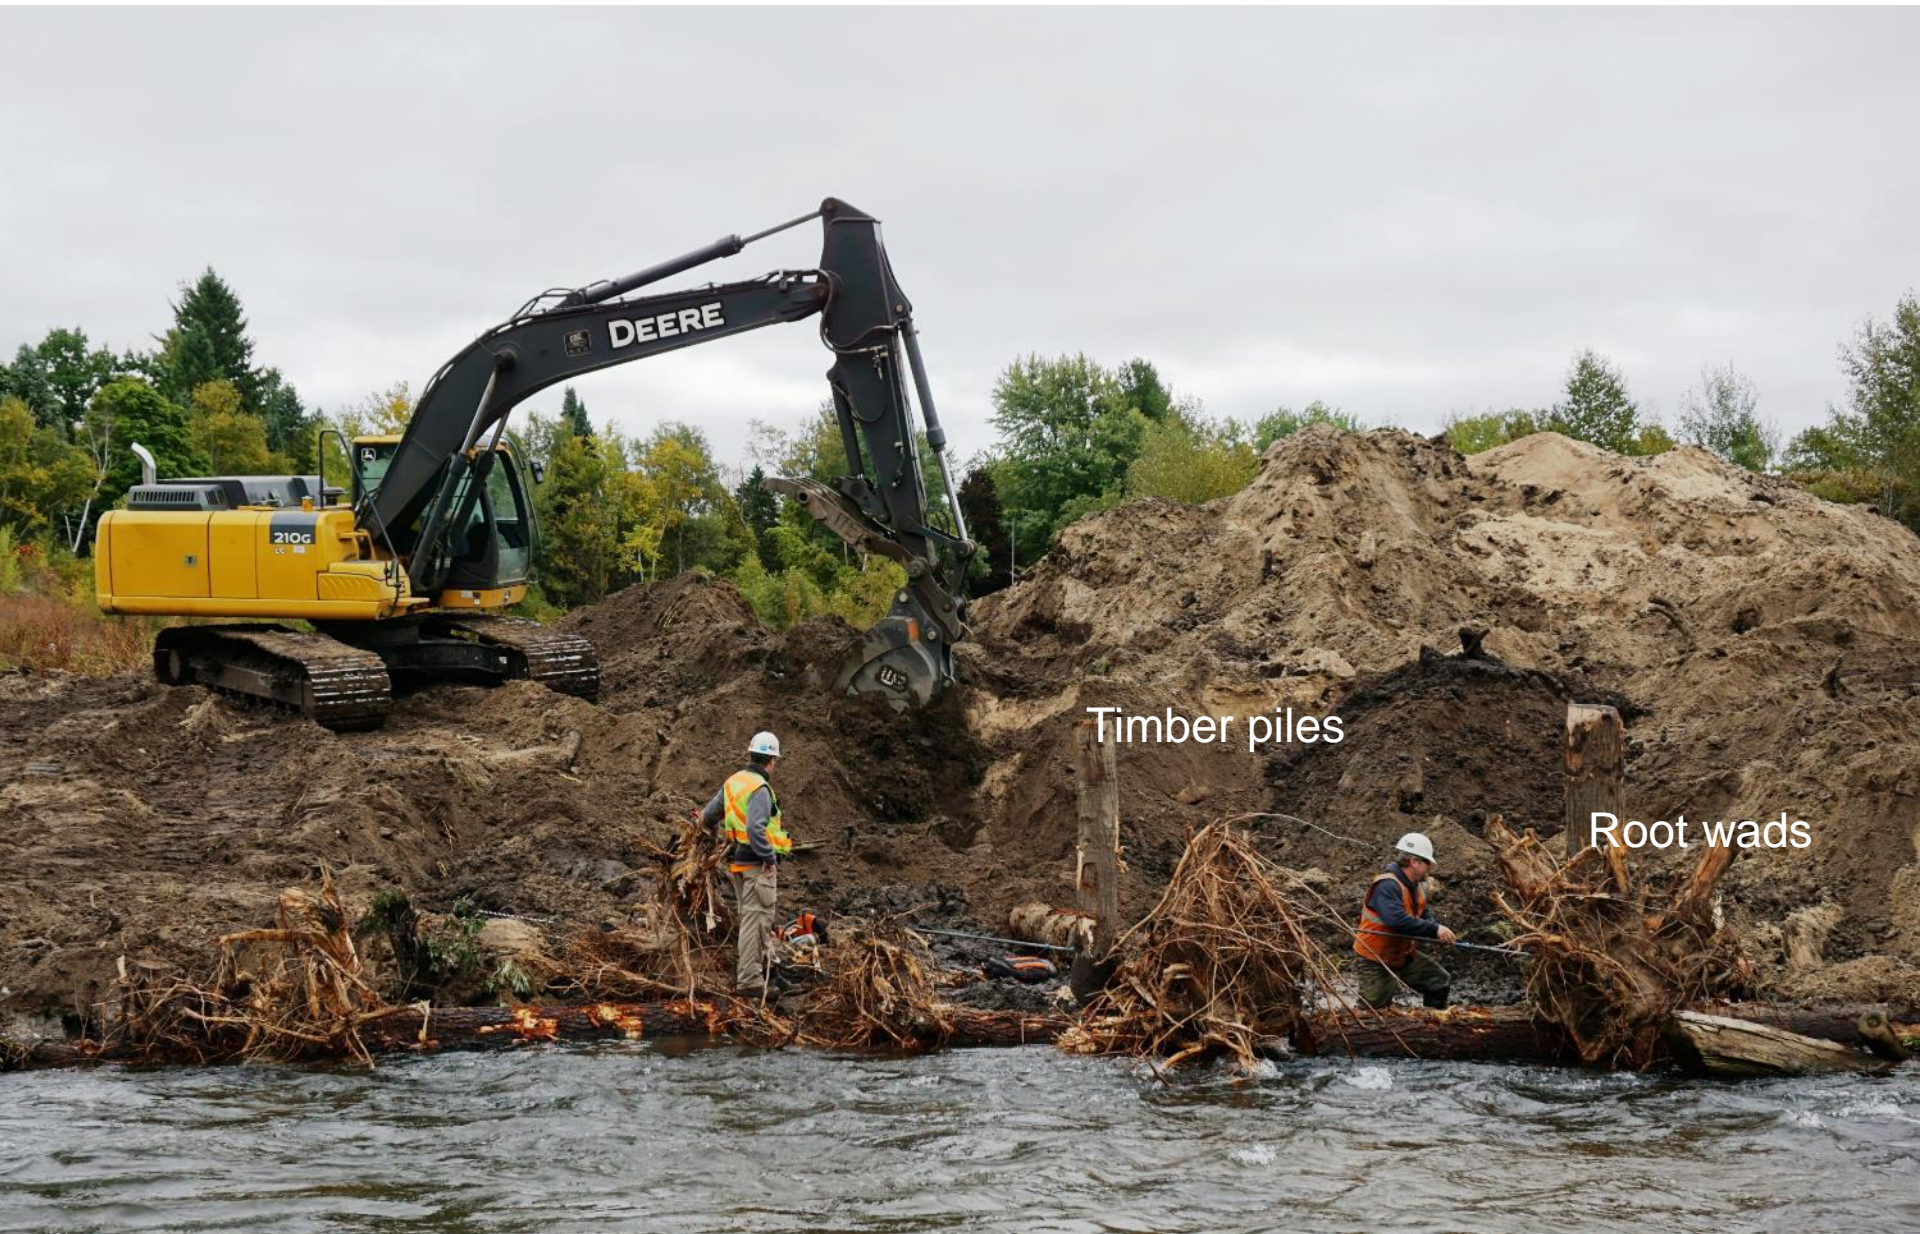
# Recessing & securing LWD into a streambank.

Timber piles

Root wads
