# Dam Removal & River Restoration Projects in Northwest Michigan

Conservation  
Resource Alliance

# Boardman River Dams

# Lake Kathleen Dam Removal & Woodland Bridge Project on the Maple River

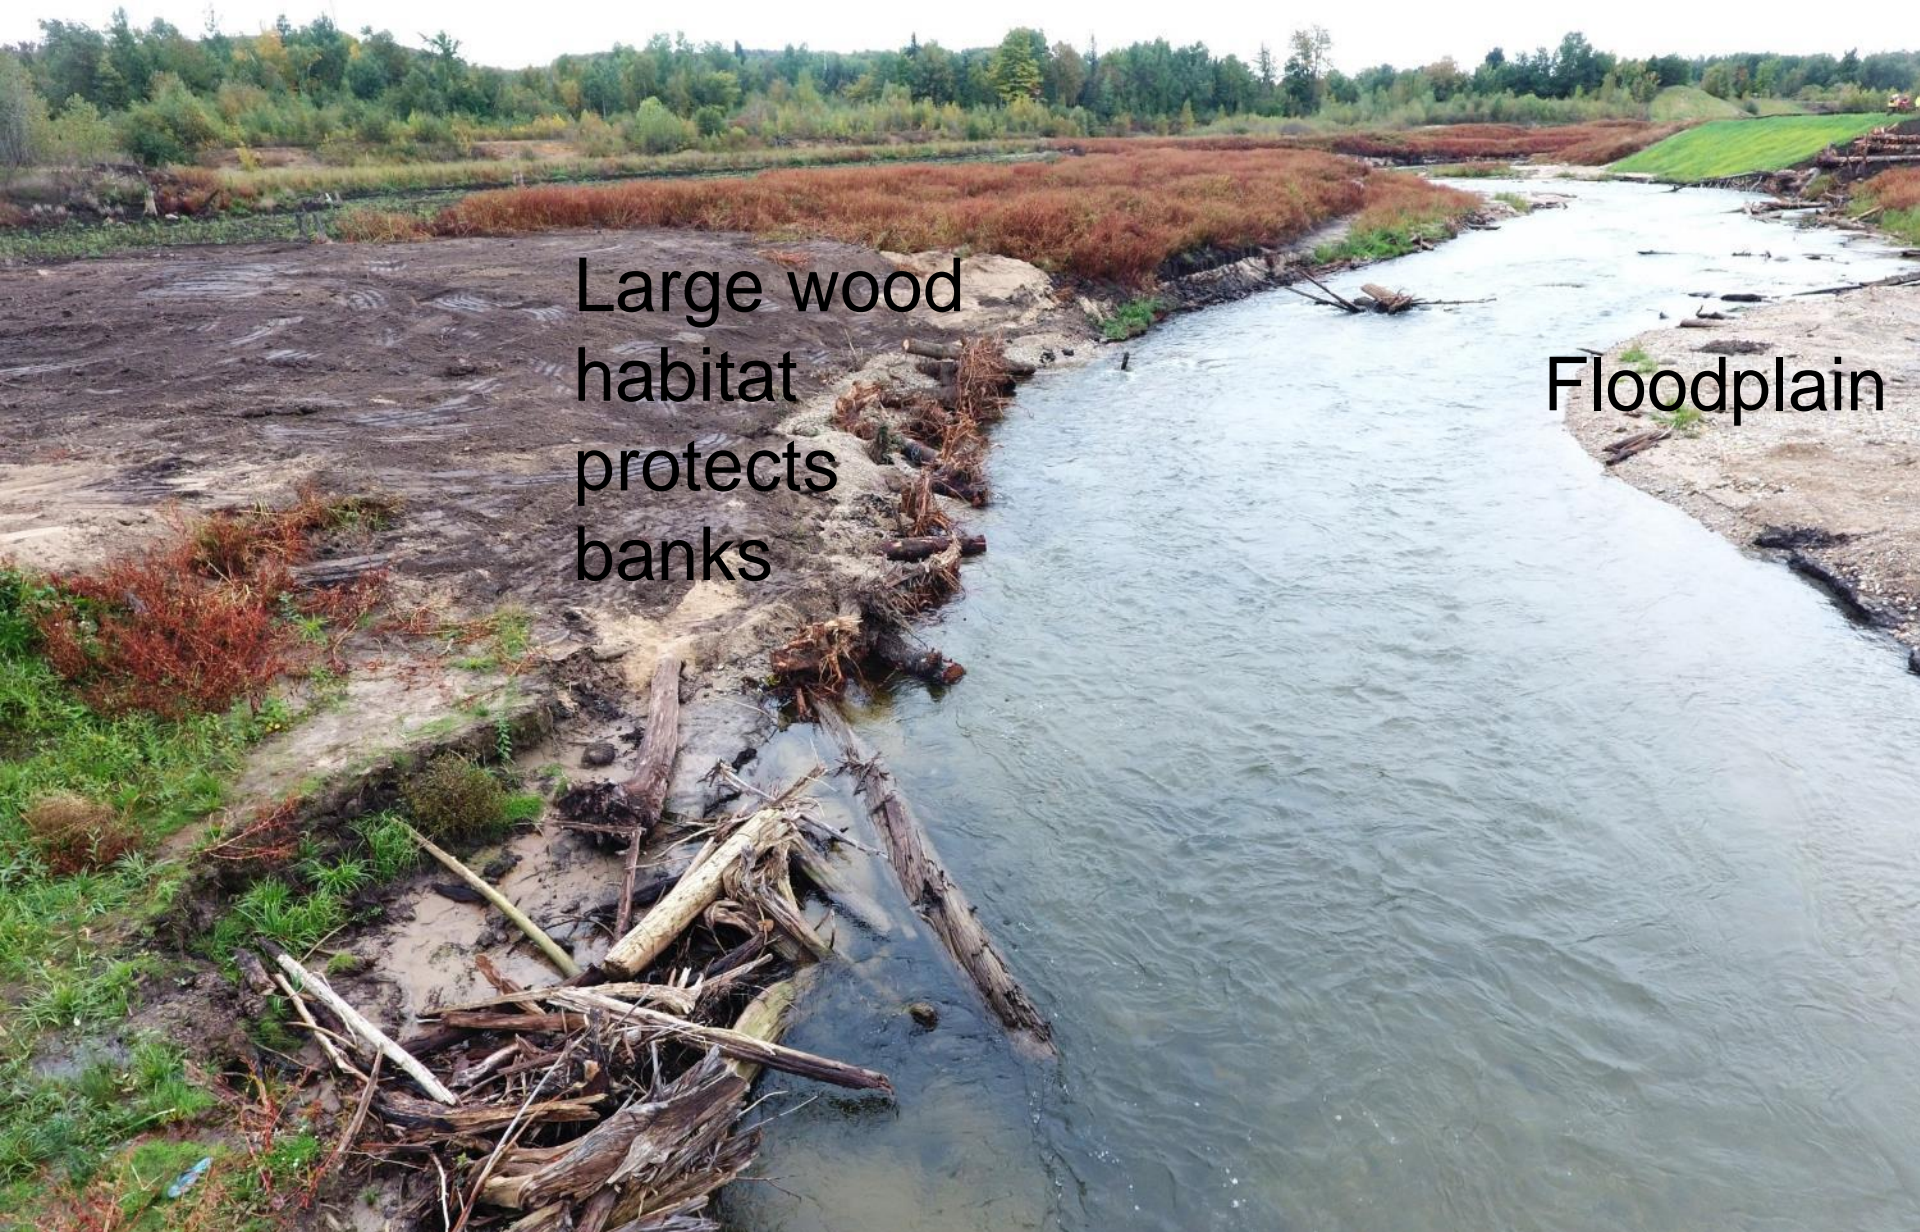
# A stable river channel...

Large wood  
habitat  
protects  
banks

Floodplain

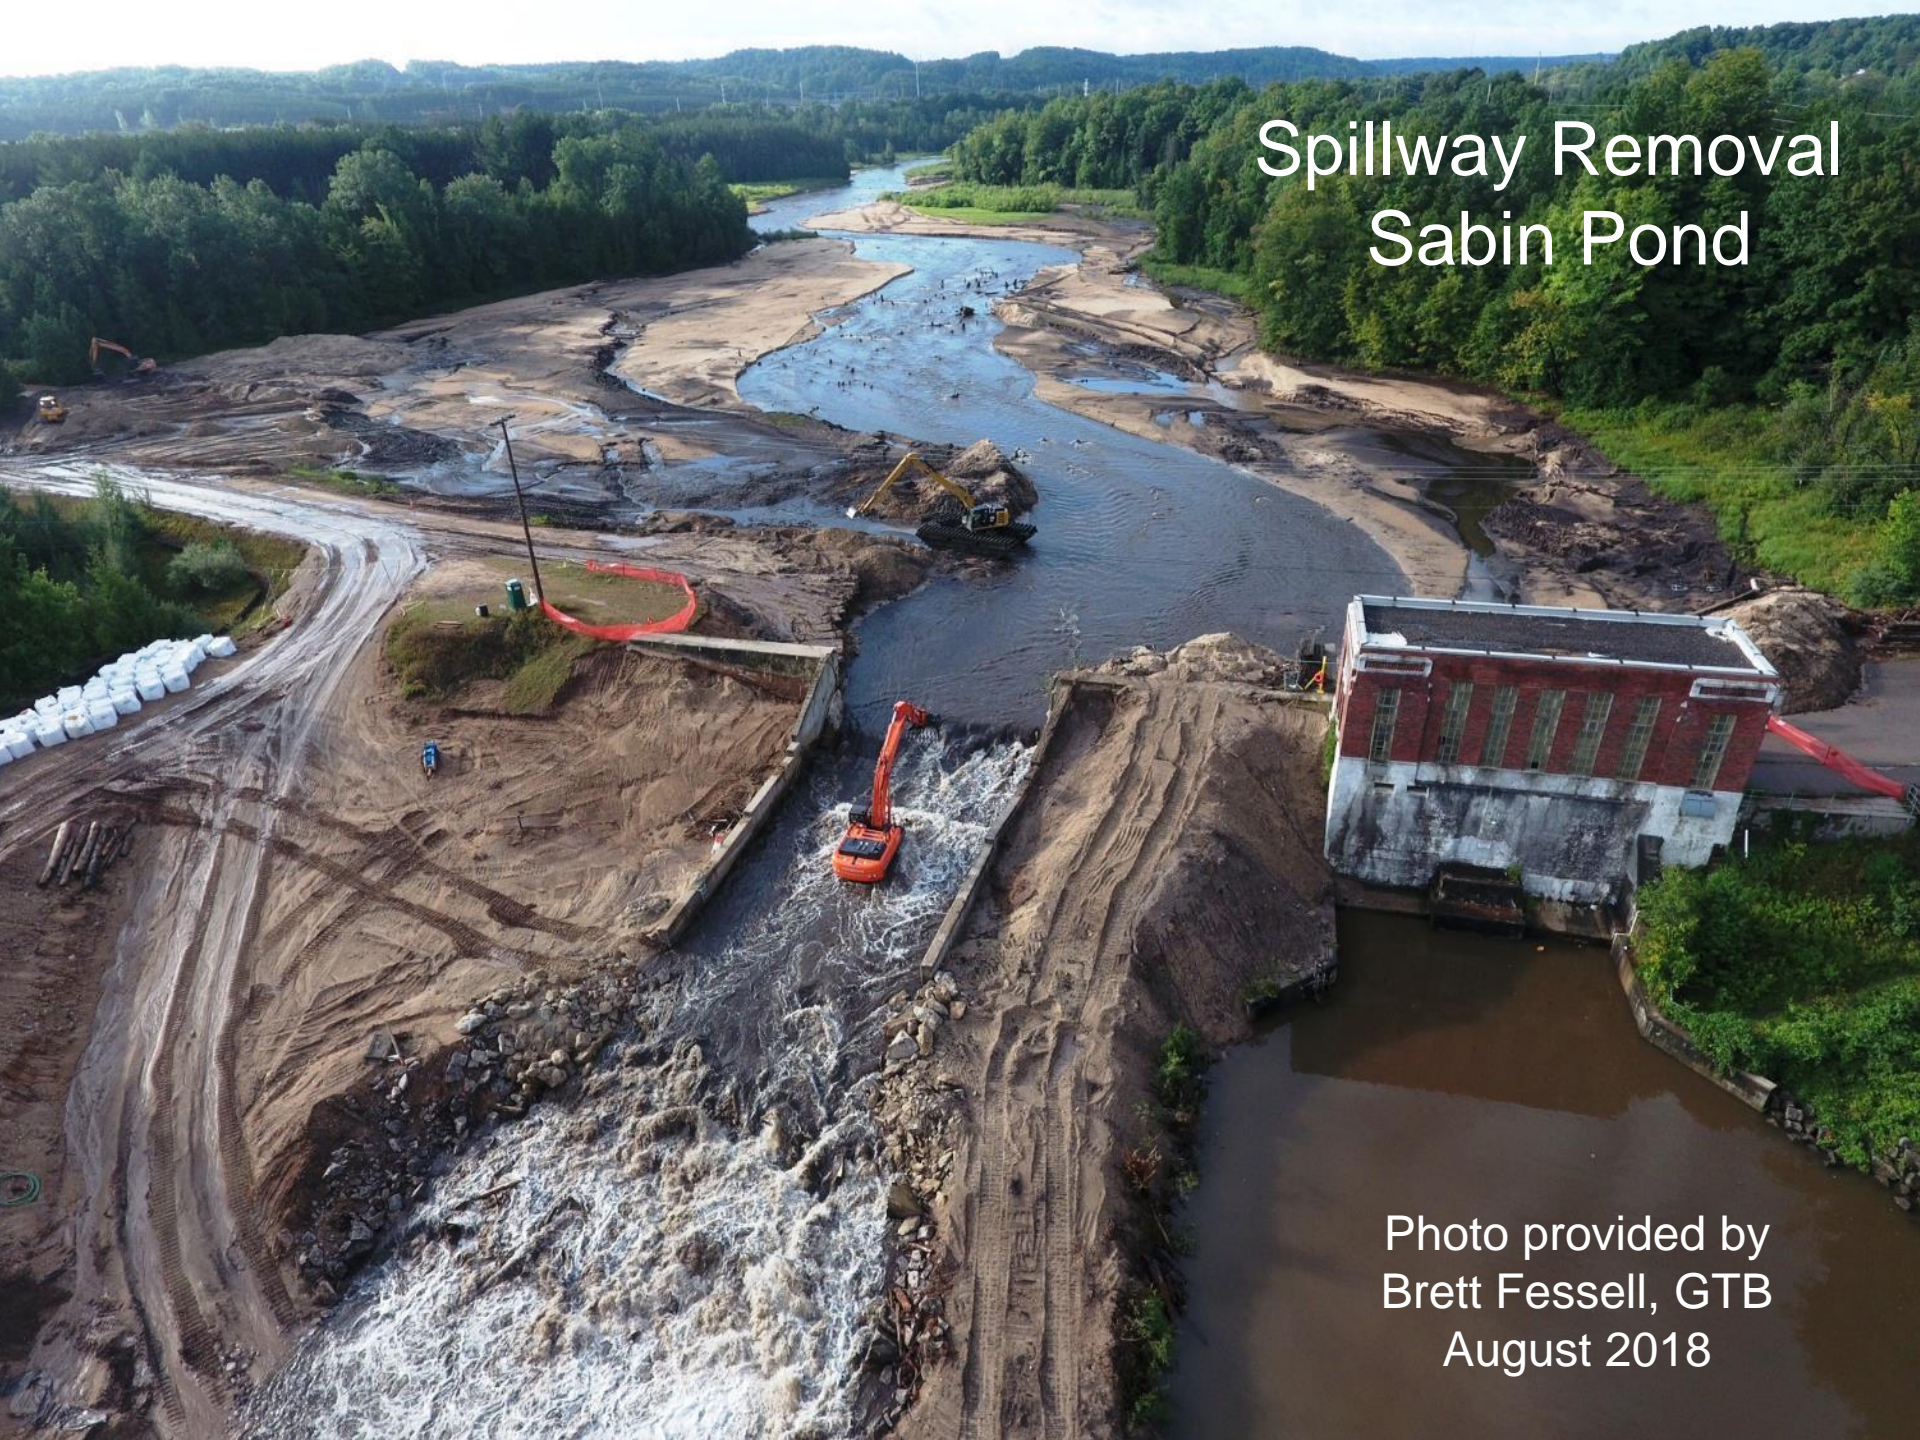
# Spillway Removal Sabin Pond

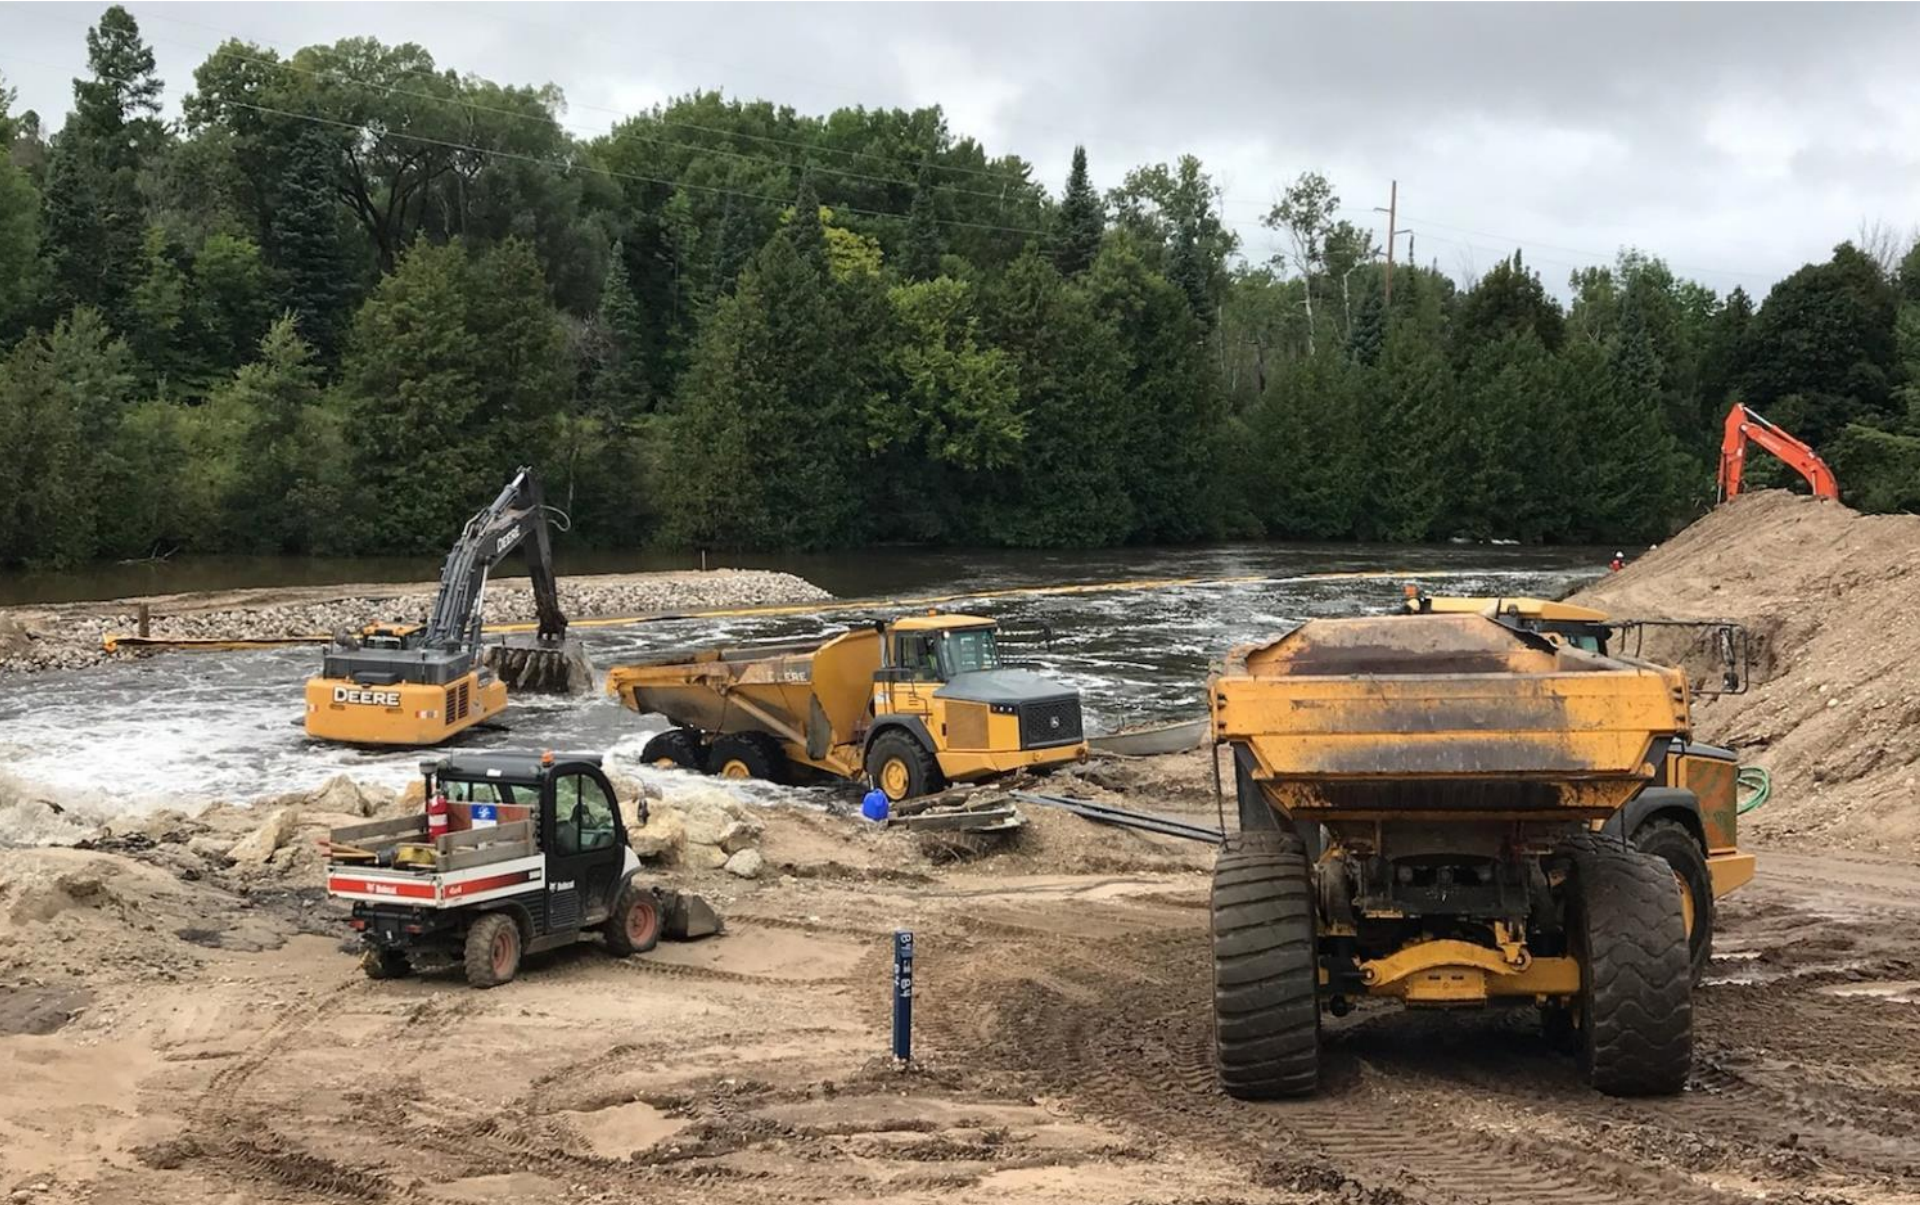
# Sediment management – moved 122,000 cubic yards of sediment

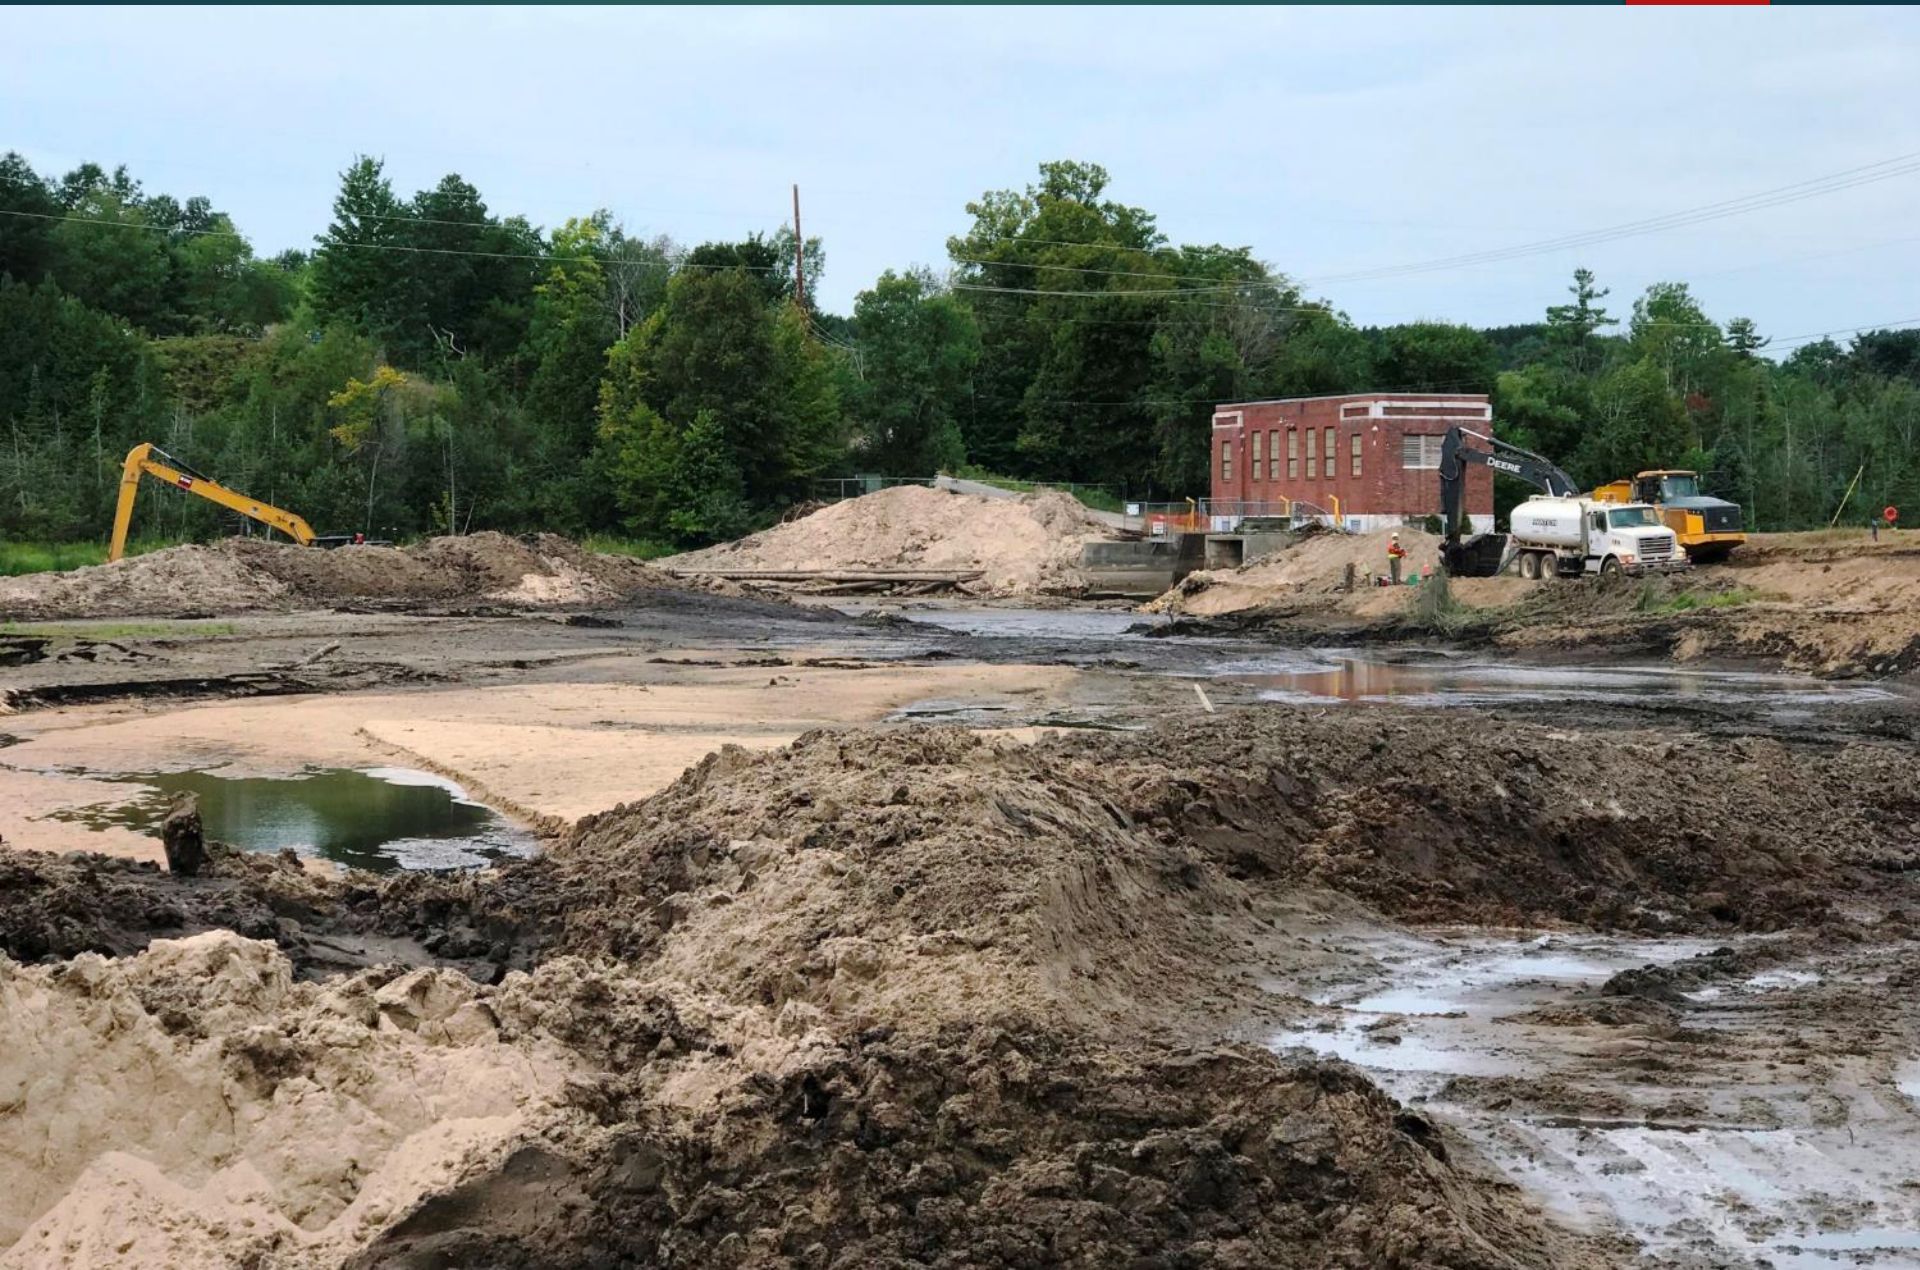
# Rainbow of sediment types (“muck machine”).

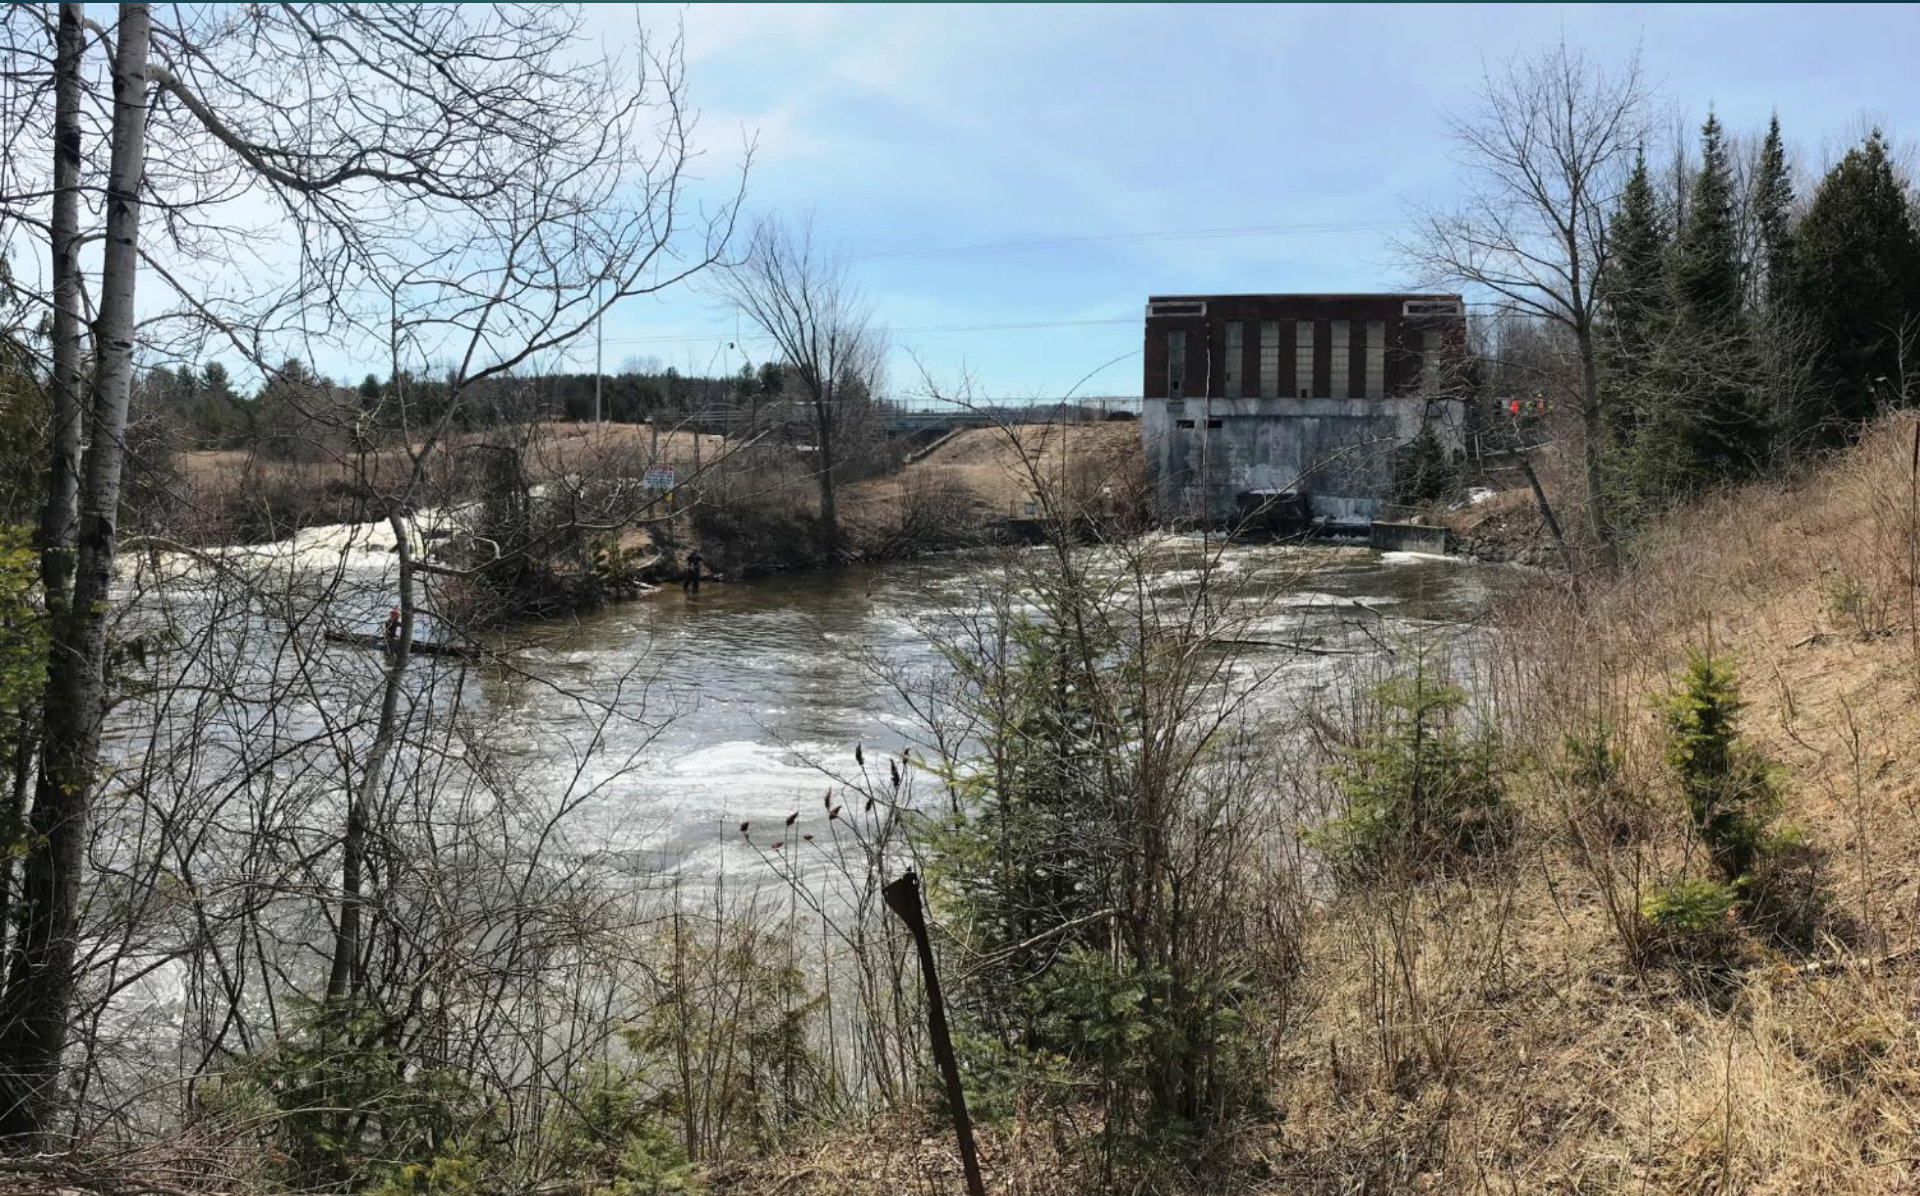
Before - Historically, river bottom was dredged down 8' in this section.

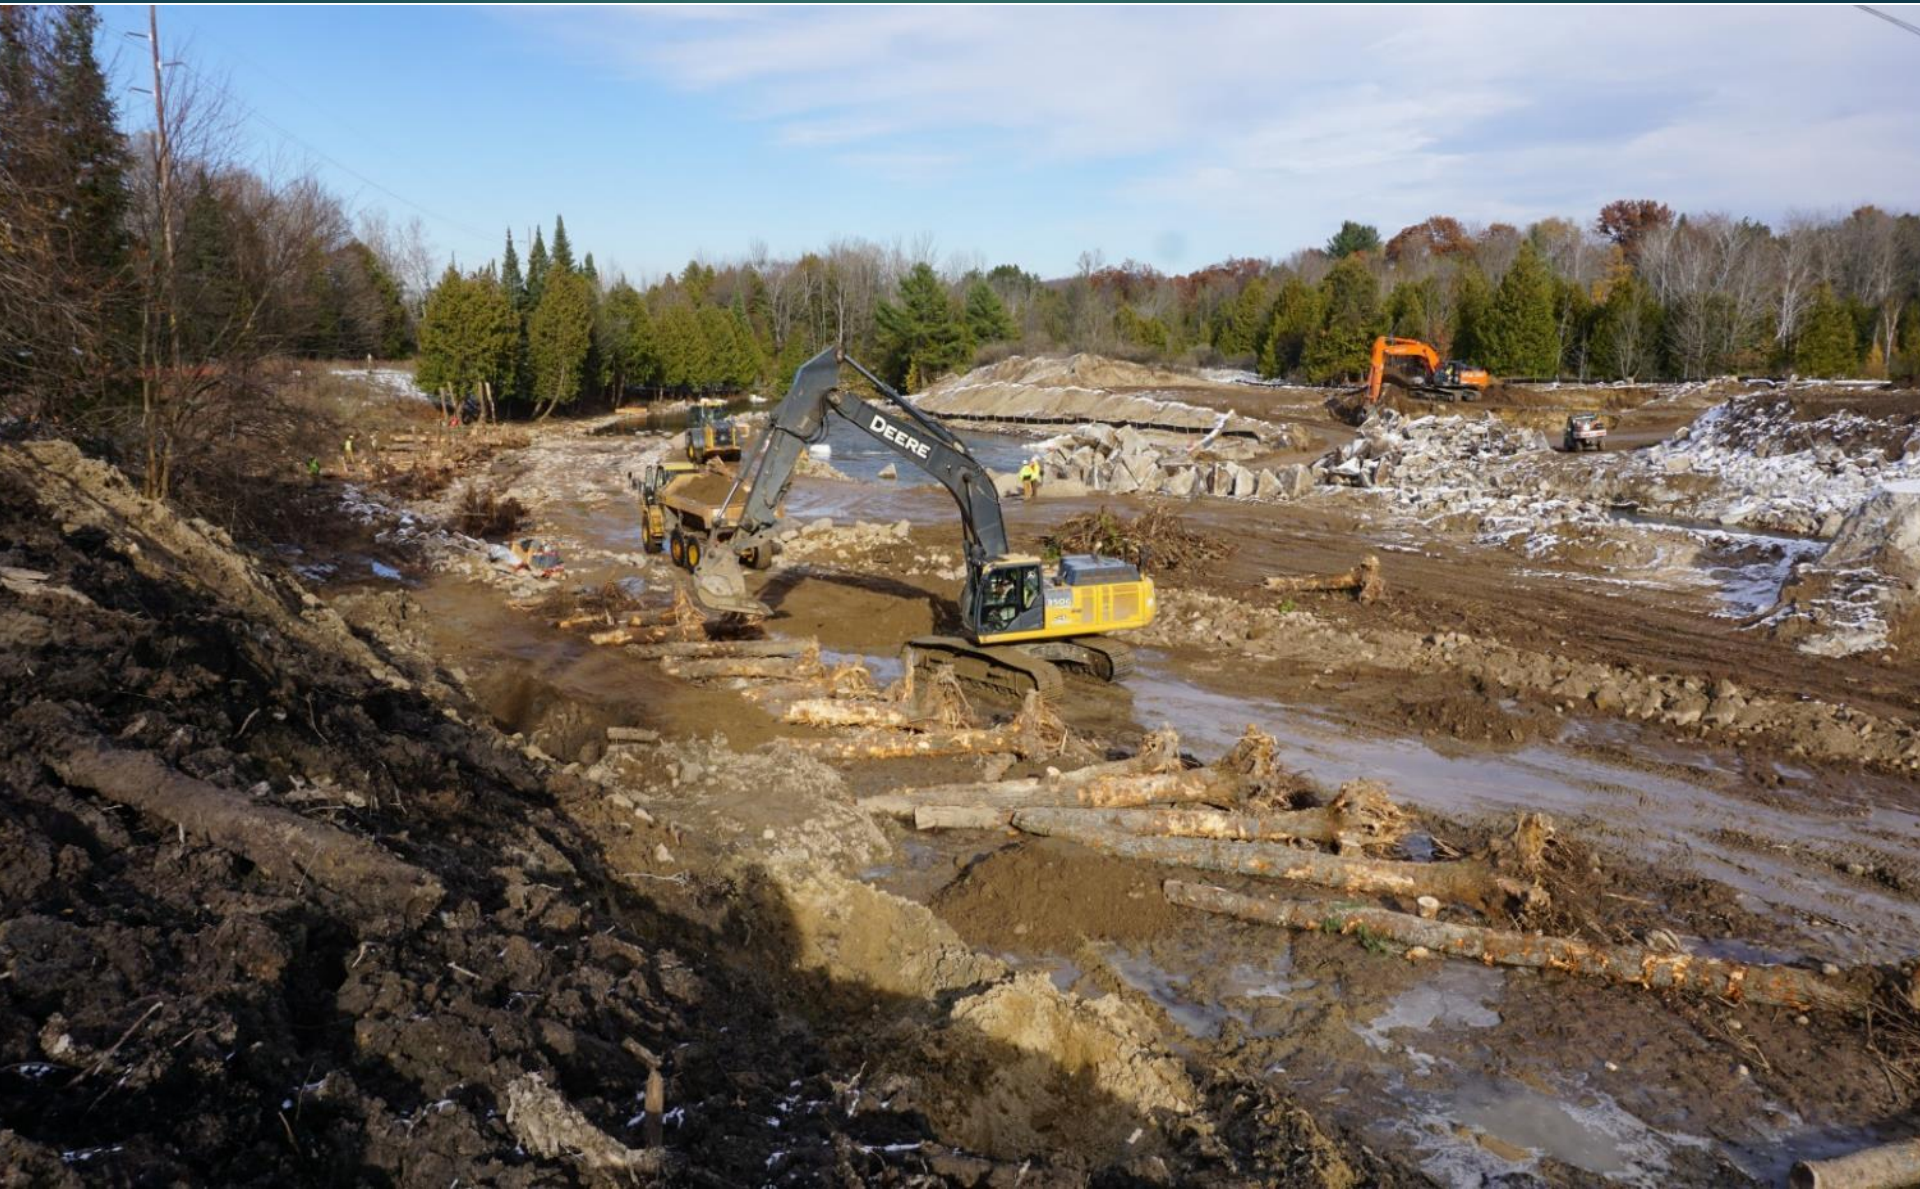
# During - Channel construction & bank stabilization

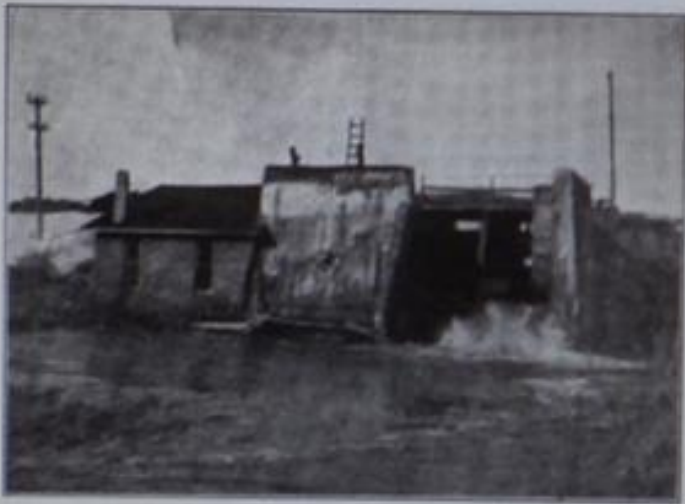
**PELLSTON, MICH.** The downstream wall (Bulkhead) of an open turbine penstock fell out into tail race in February, 1912. The bulkhead was badly designed and constructed. It had no reinforcing steel in it and the concrete was mixed of gravel and sand taken out of an old river bed. The plant was then in receiver's hands and has since been sold to the Cheboygan, Michigan, Light and Power Company and will be repaired this spring.

**PELLSTON, MICH.** Hydro-electric plant was partially wrecked in April, 1912, by the collapse of a concrete wall which served as the downstream bulkhead of the turbine chamber. Cause amateur engineering and criminally bad concrete.

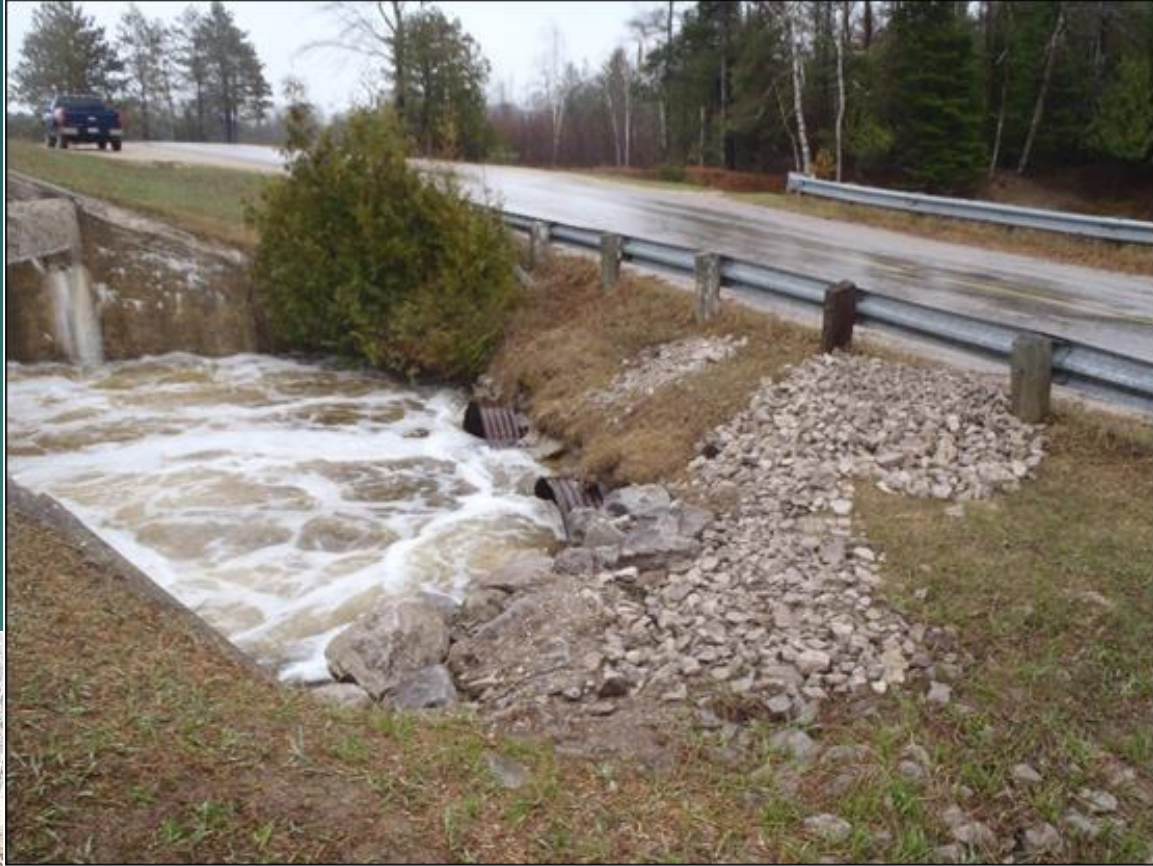
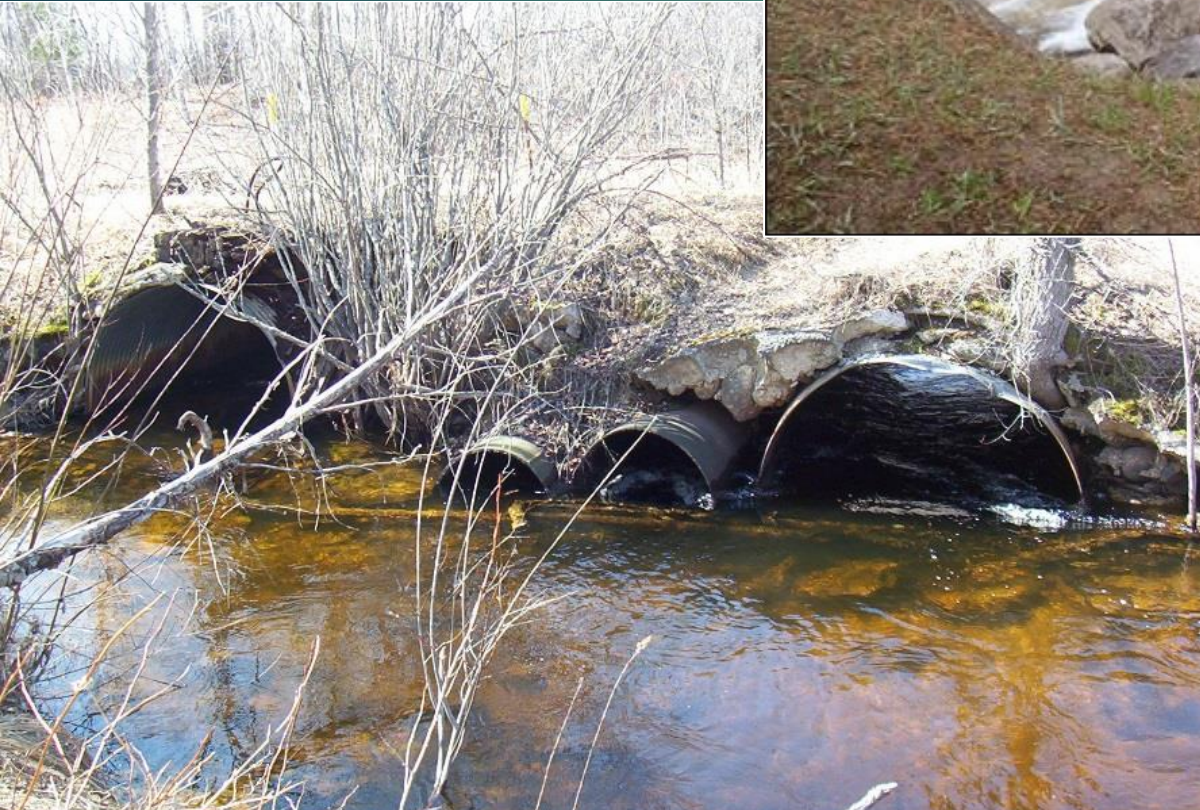
Woodland Road  
prism just  
downstream of  
dam began to fail  
during spring high  
water 2014.

Neighboring  
pipeline crossing  
on the East Branch  
of the  
impoundment  
needed  
replacement.

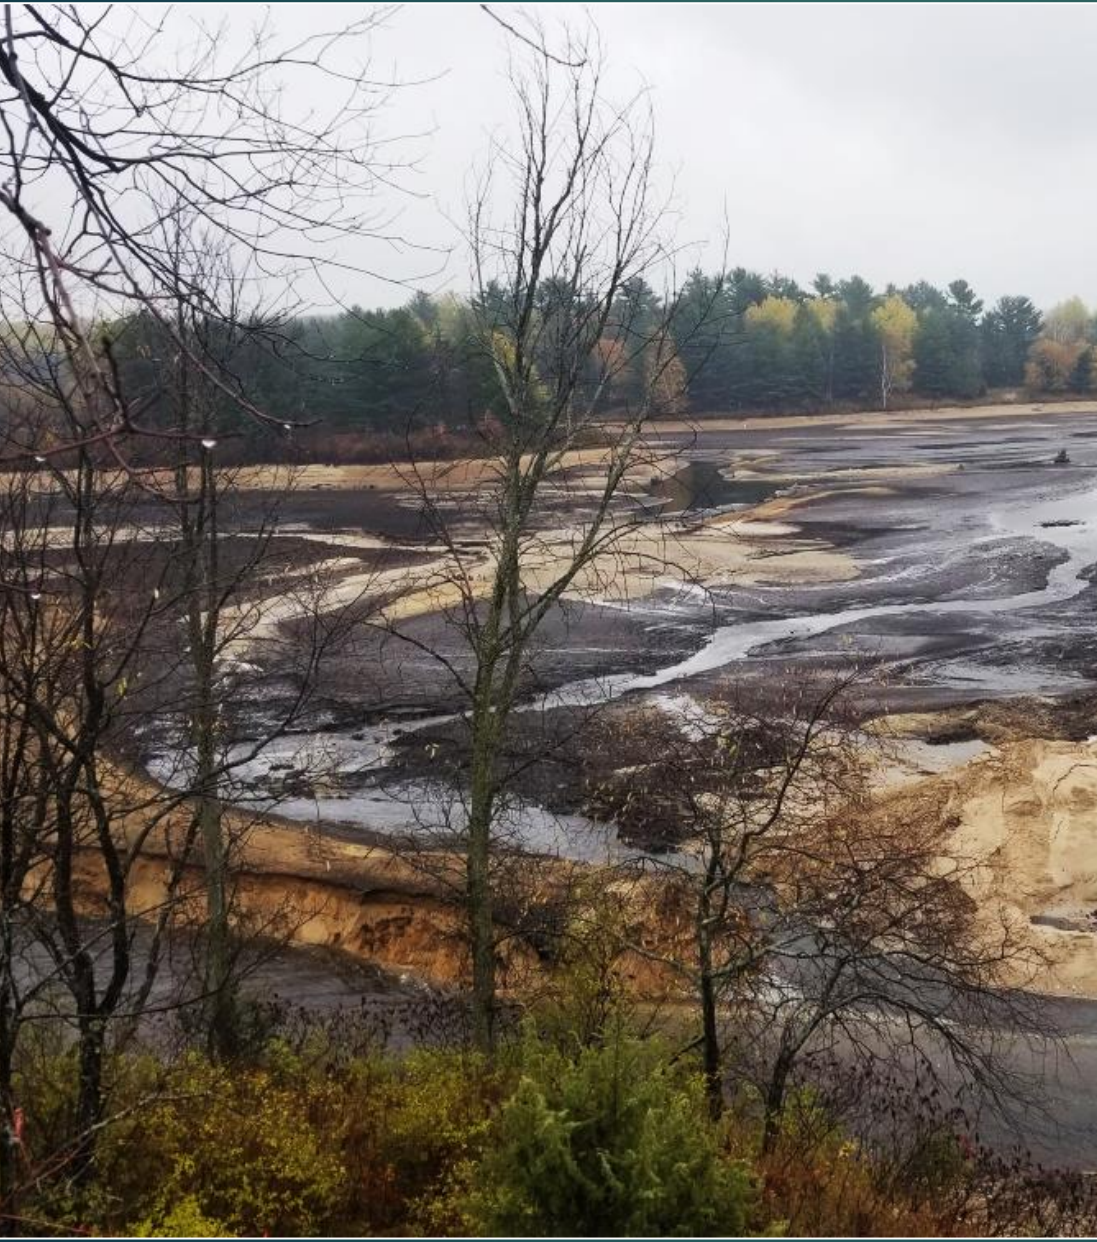
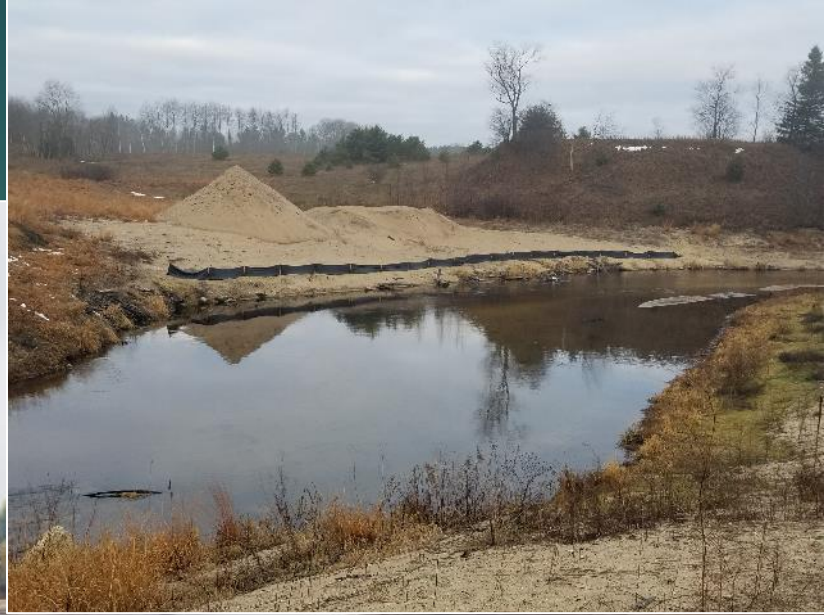
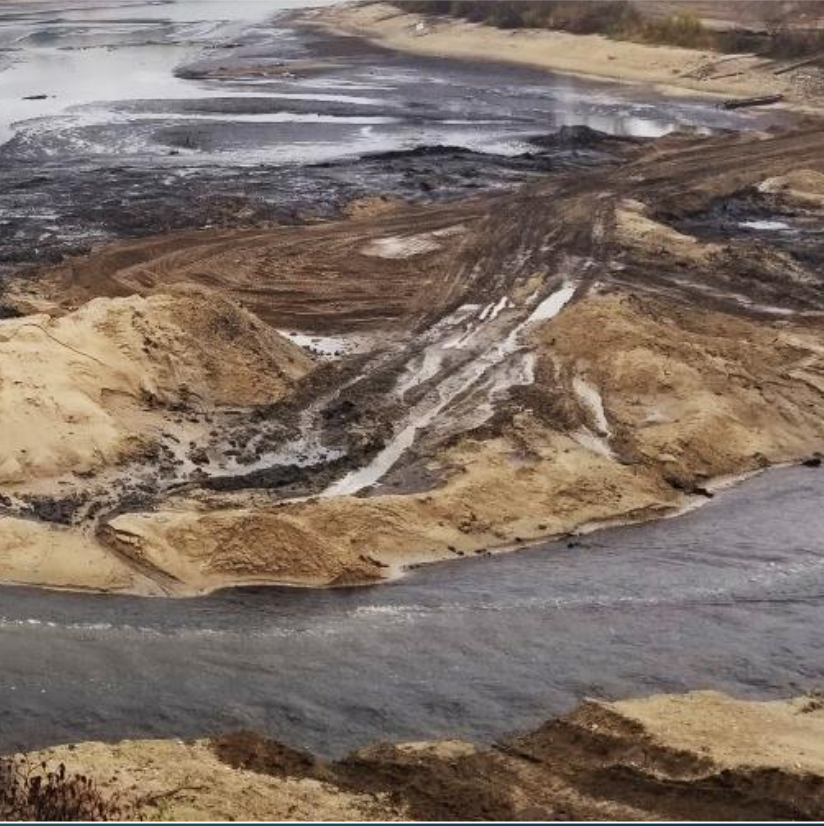
Sediment management – in total estimated 90,000 cyds.

Drawdown  
& removal

Dewatering – gravity  
fed siphons

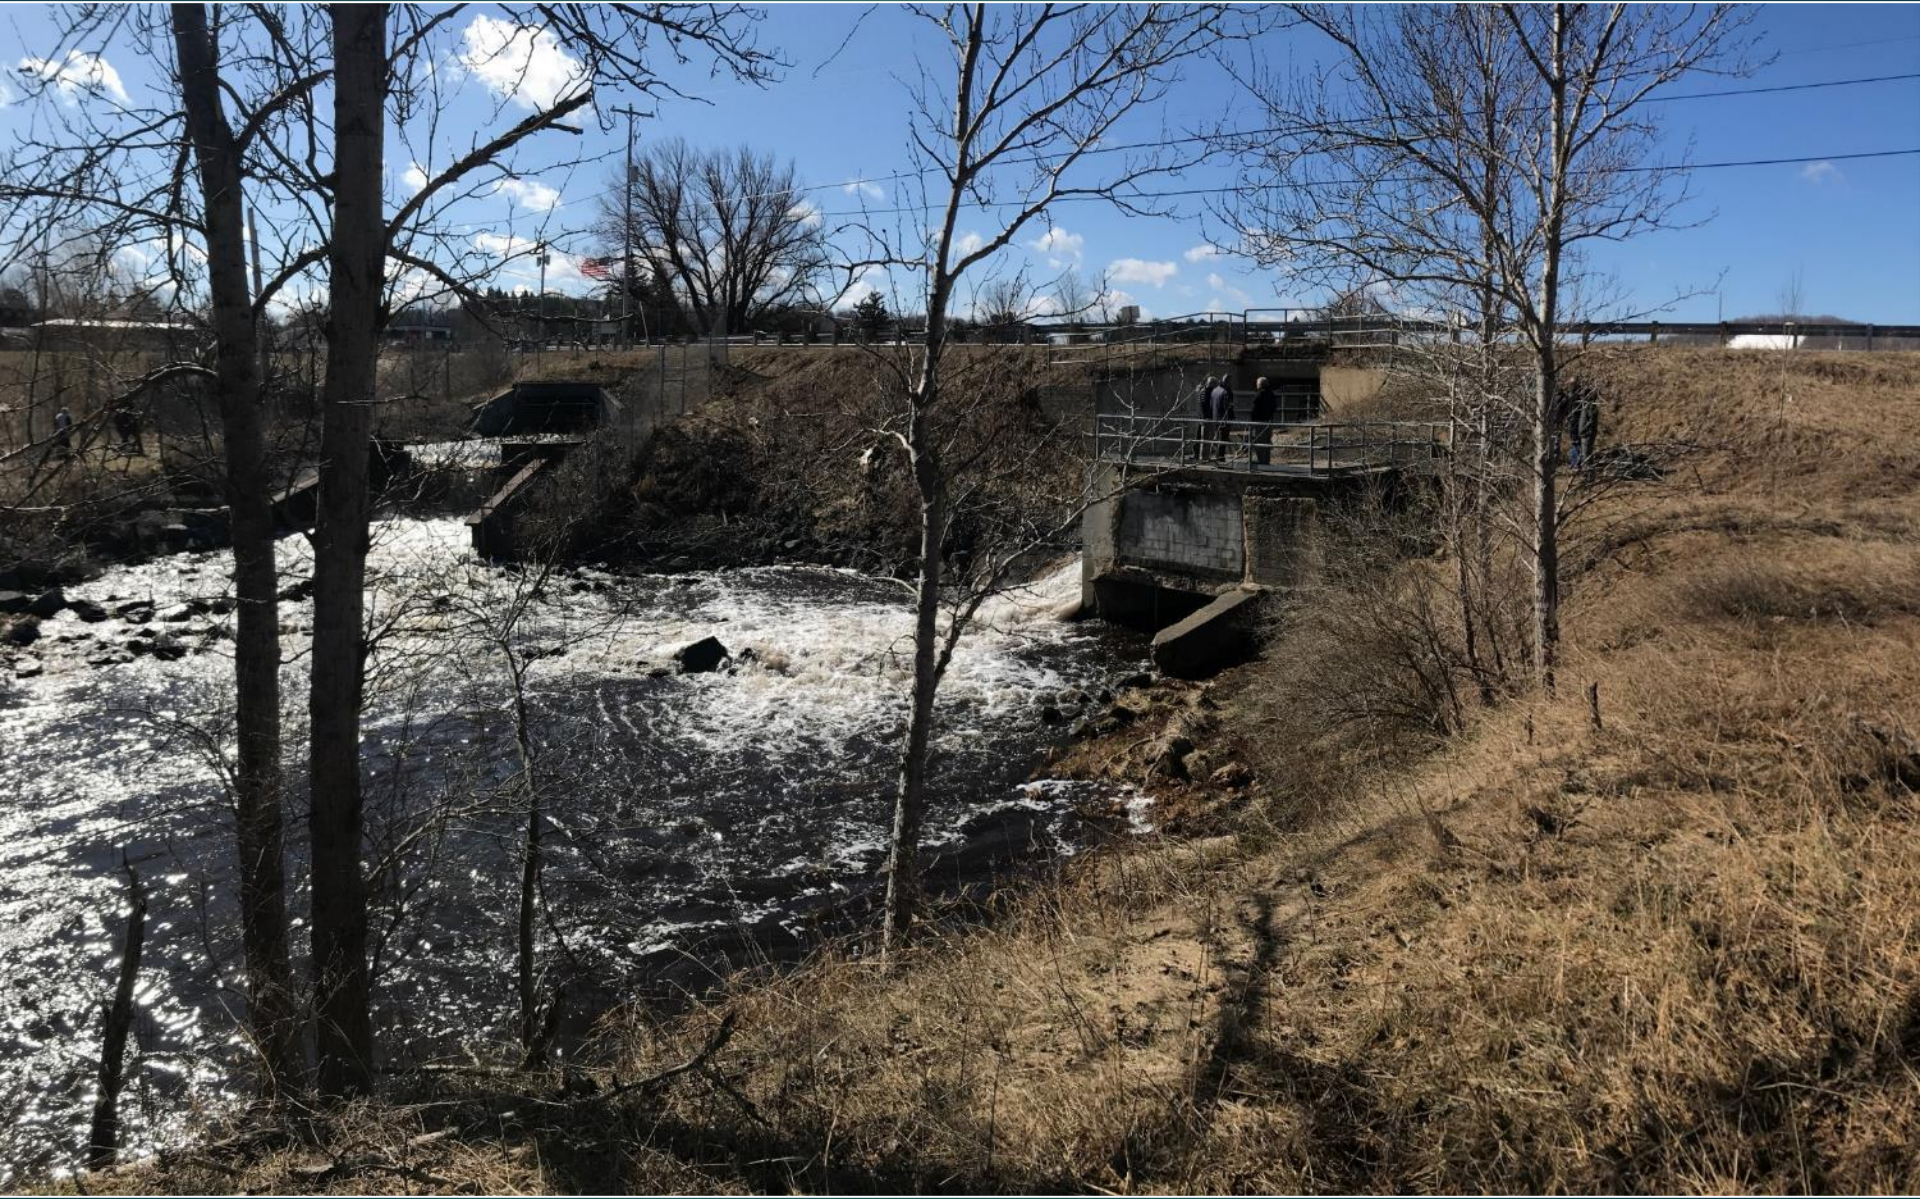
Current Boyne Falls Dam – fair condition, significant hazard potential rating, 41.62 miles US & 6.8 miles DS
